**Application for Review and Public Meeting
Franklin Heritage Commission
Franklin, New Hampshire**

38 E. Bow Street Narrative

38 E. Bow Street, Franklin, NH

Building Evaluation by Mid-South Engineering – 12/30/2022

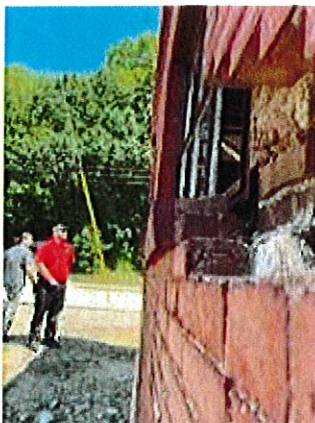
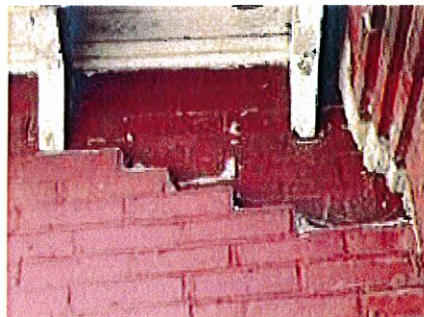
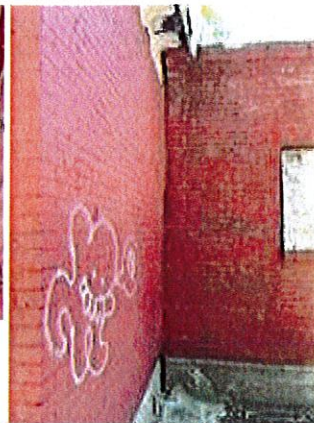
Notes: July 28, 2022 photos and observations

Attached photos illustrate shifts in multiple masonry walls that need inspection and/or repairs completed by a qualified person OR documentation from a qualified engineer stating that conditions are safe.

- Inspector Notes:**
1. Demolish the structure and fill the foundation hole.
 2. Repair the structure to current codes and standards and bring the building to a safe condition more in line with the City of Franklin's efforts and downtown vision.
 3. Contract an Engineering company/Engineer to determine the requirements to make this structure safe, and complete minimal repairs to prepare for possible sale. In this case the following applies:
 - a) Seller must disclose Property Maintenance Complaint and generate a correction plan.
 - b) Roof must be repaired to eliminate further property degradation.
 - c) Front entry porch roof must be repaired or removed.
 - d) Foundation and wall shifting to be addressed as outlined within the aforementioned Engineering report.
 - e) Windows to be replaced or covered with appropriate exterior material

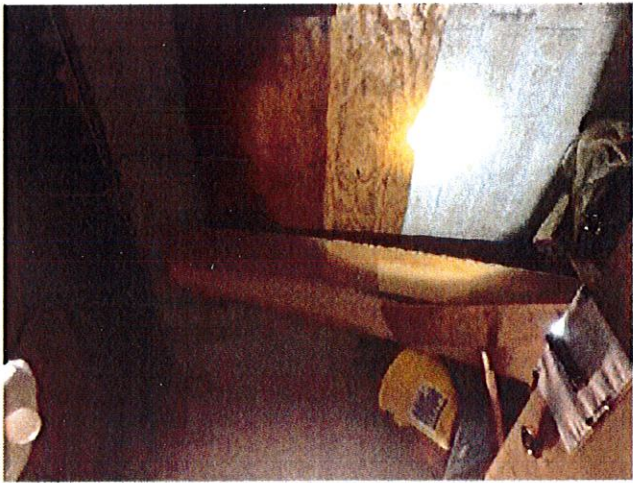
Attic of western structure

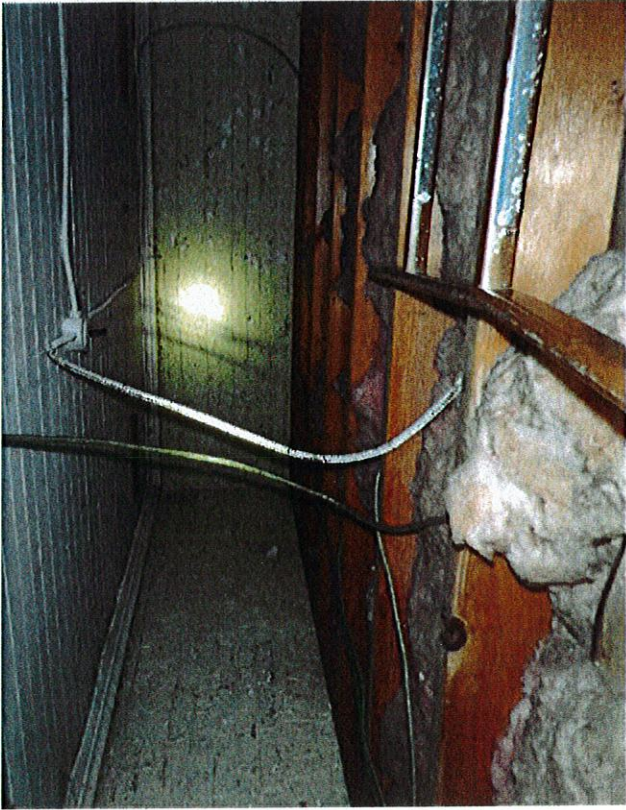
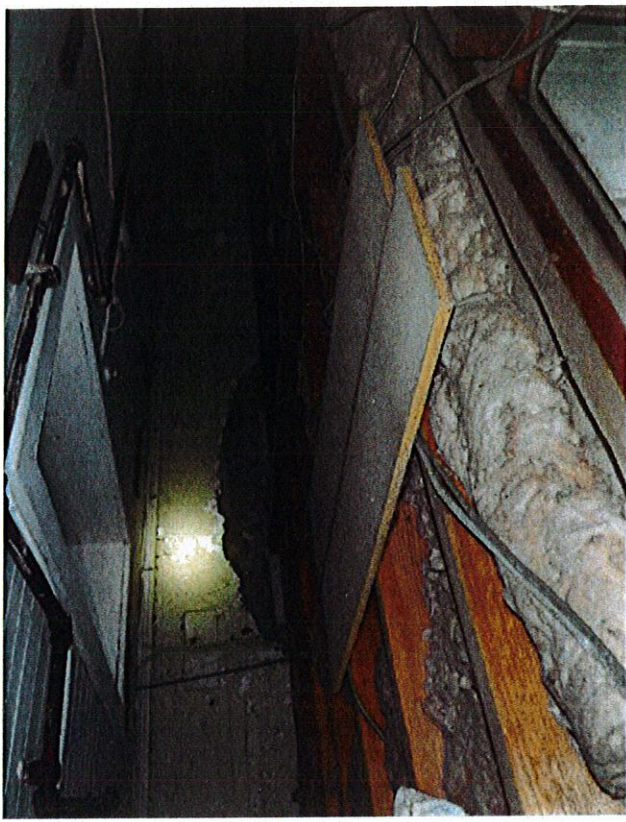
Interior of building

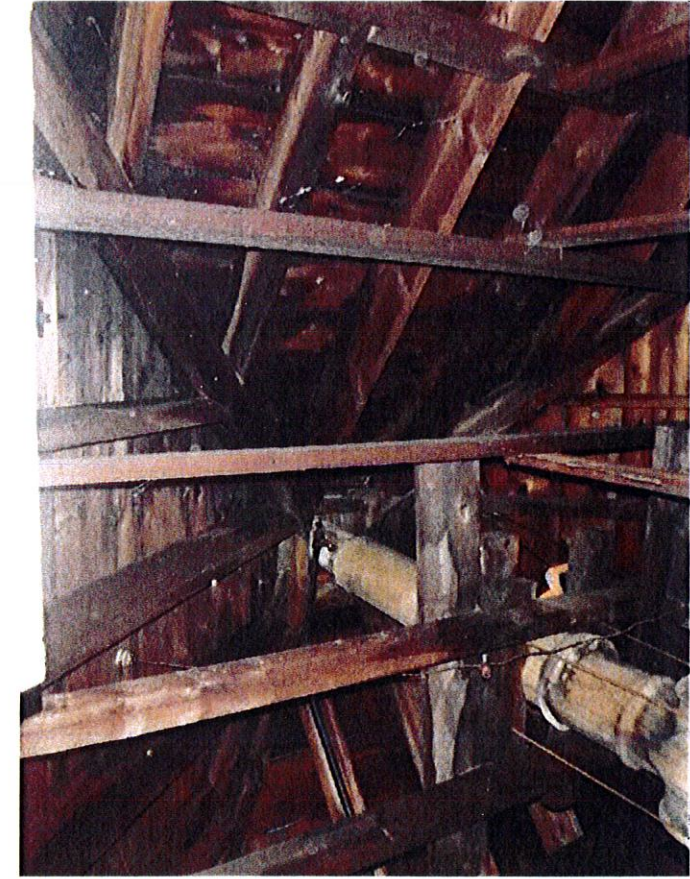
Attic of western structure

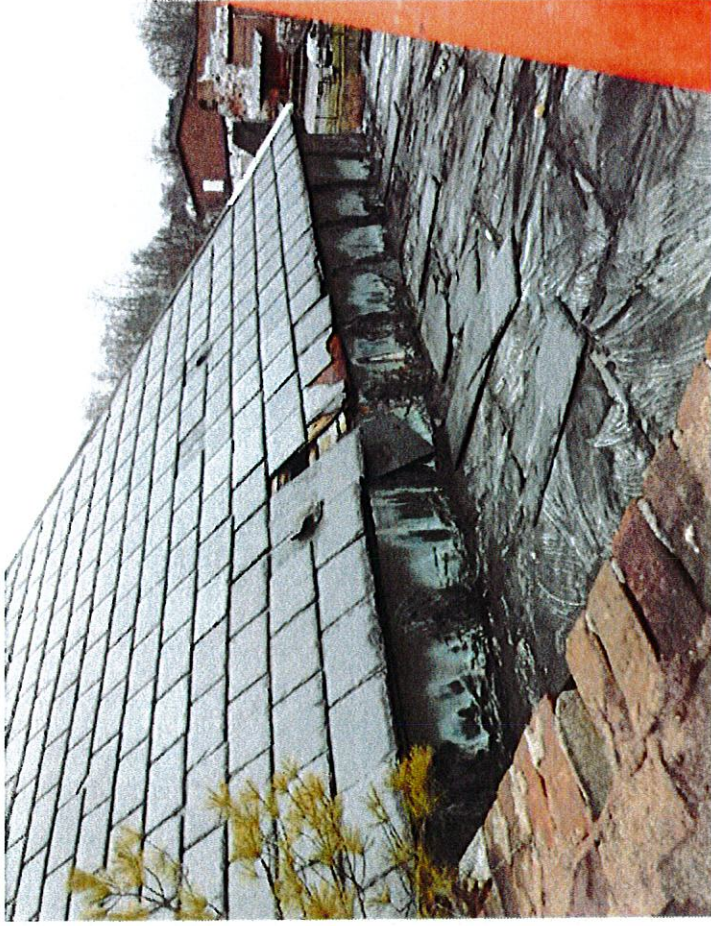
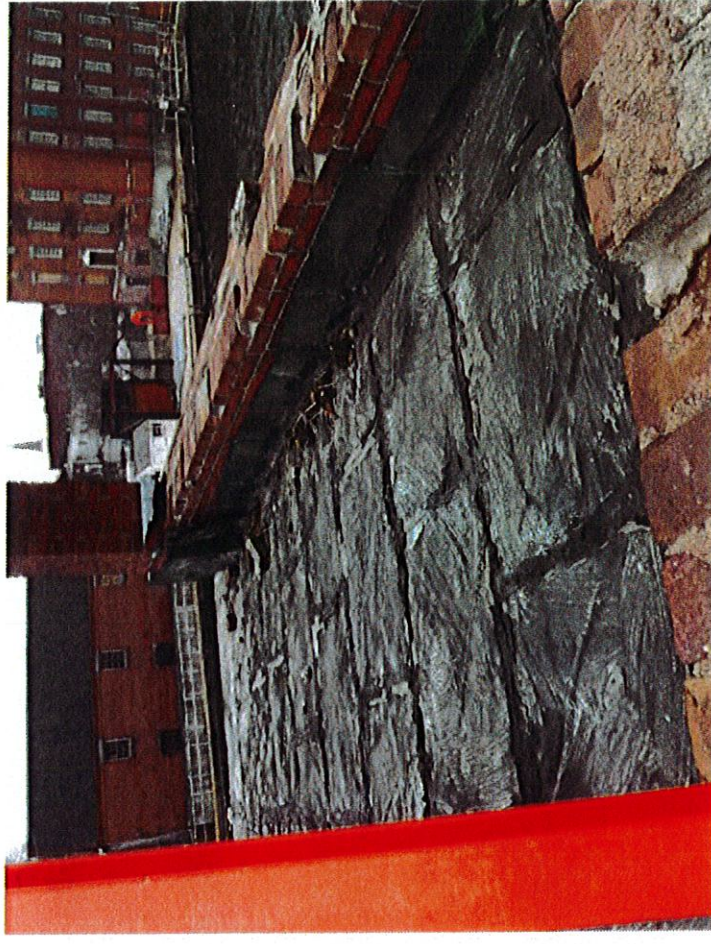
13. The building has settled slightly to the Northwest corner. The settlement is estimated at approximately 1-2 inches. This settlement has caused the large cracking in the brick work at the upper corner of the South side of the West wall. Also, the North wall where it meets the main building has pulled away from the main building leaving a large space at the top under the roof line. Upon further inspection, it does not appear that the cast in place frost wall was tied to the older building granite block foundation at the North wall face or the cast in place retaining wall at the rear. Also, there appears to be no tie between the two walls where the brick has pulled away due to the settlement.

Cracked walls

- 4) The crack in the wall at the North face of the building where the two buildings meet should be spray foamed to fill the void to eliminate the entrance of rodents and weather. We would recommend structurally reinforcing this corner. This could possibly be bent plate in the form of an angle and bolted through the walls to create a more stable corner.

- 5) The crack on the West wall in the SW corner should also be sealed with foam to minimize weather penetration. A steel plate secured to the wall to stiffen the wall in this area may be required.

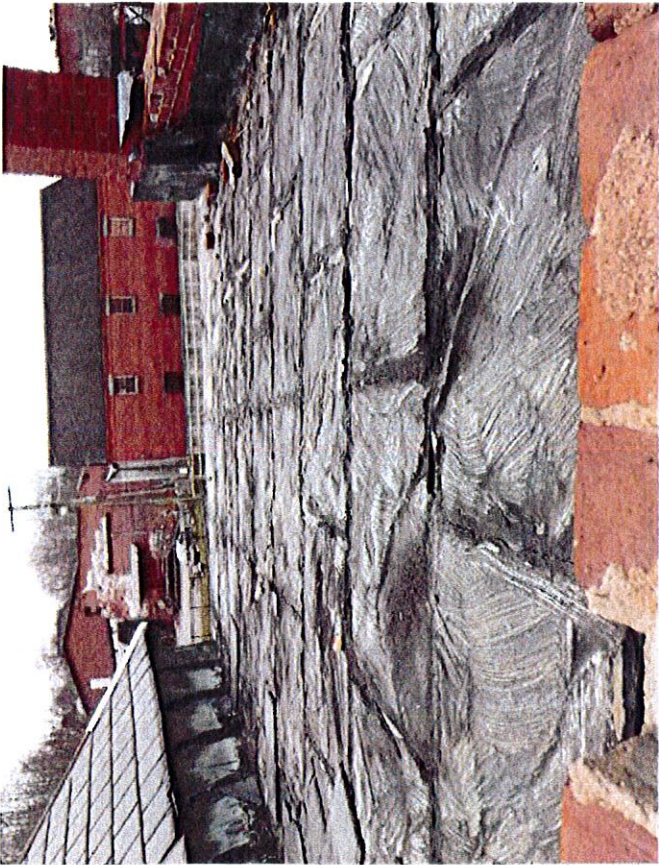
15. Daylight could be seen in several locations along the roof line where the copper roofing has become unattached. Daylight could also be seen coming through the upper North section of wall where space had opened up due to the settlement in the NW corner.

Damaged and leaking roof

- 1) Repair the hole in the roof of the original building to avoid any potential entrance of bats or other vermin and replace the slate or apply some form of asphalt or bituminous patch to maintain water tightness and eliminate any rot developing in the existing exposed roof sheathing.

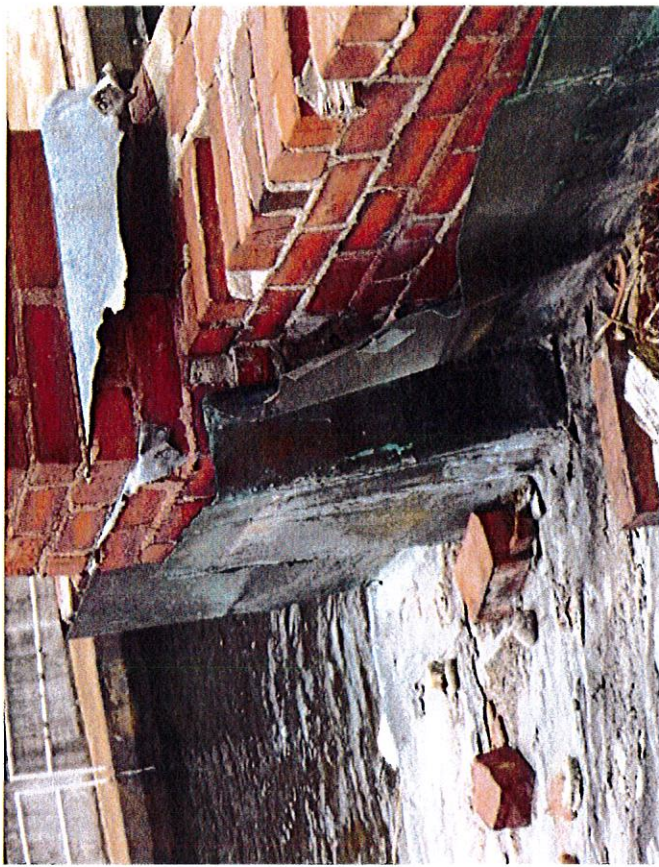
Damaged and leaking roof

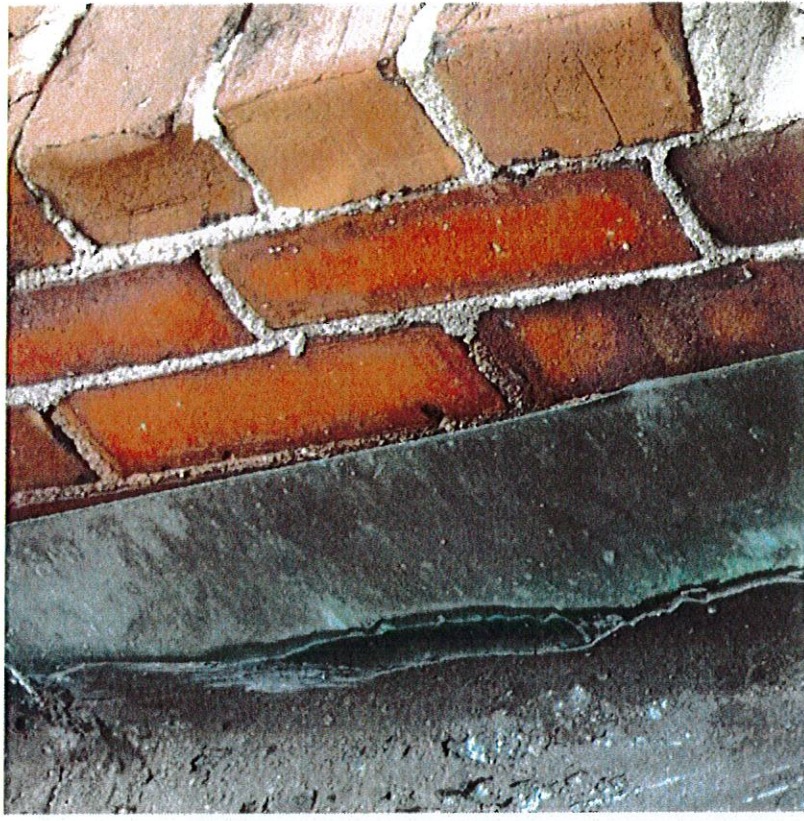
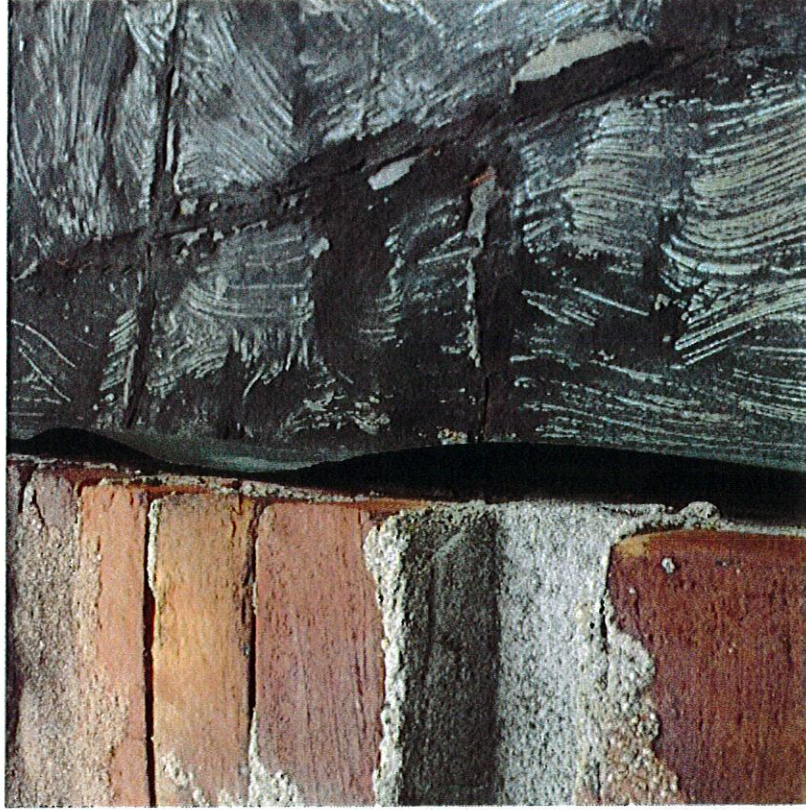
Damaged and leaking roof

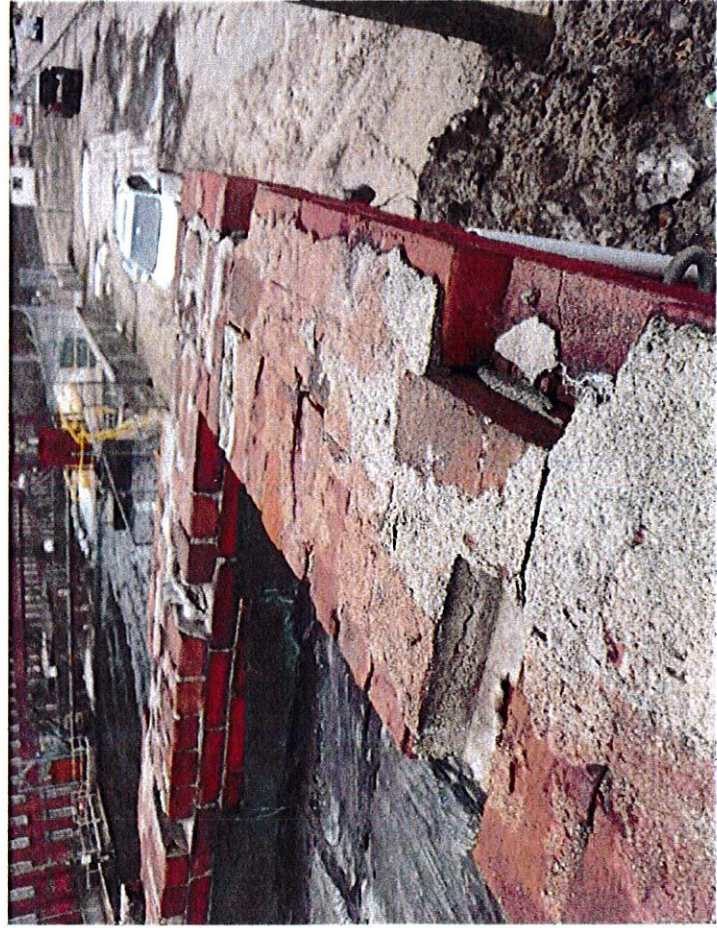
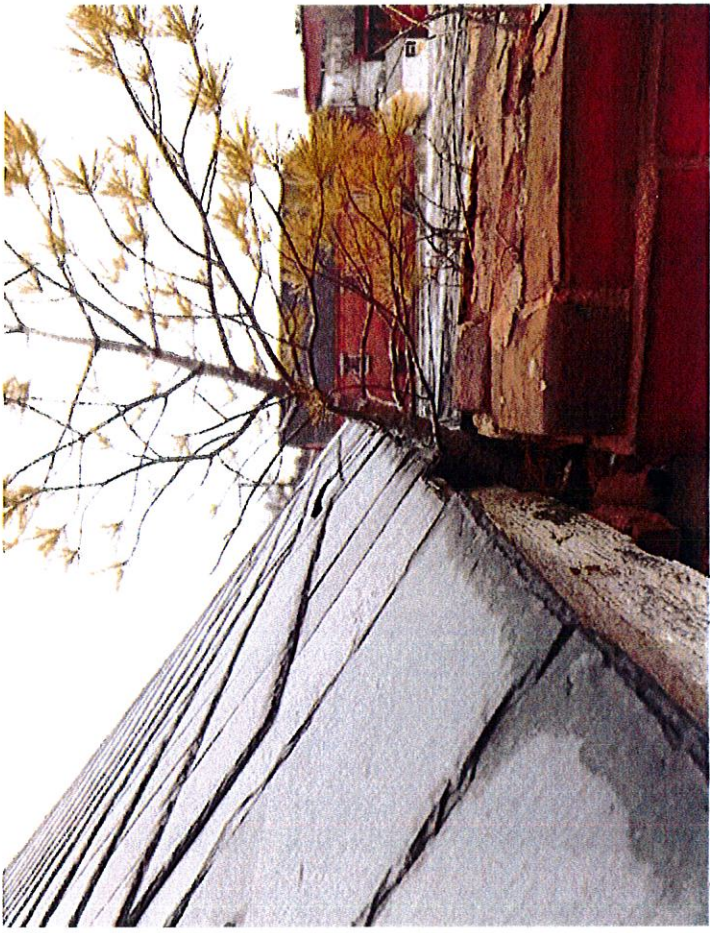
Damaged and leaking roof

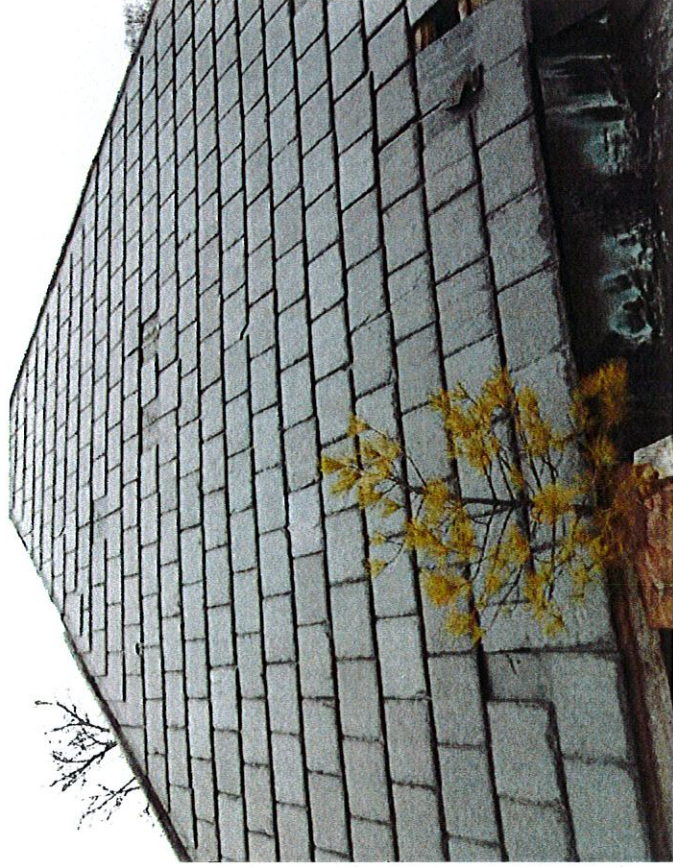
Damaged and leaking roof

- 8) Secure the roof of the newer building by sealing the copper flashing against the parapet walls to eliminate moisture from reaching the room below.

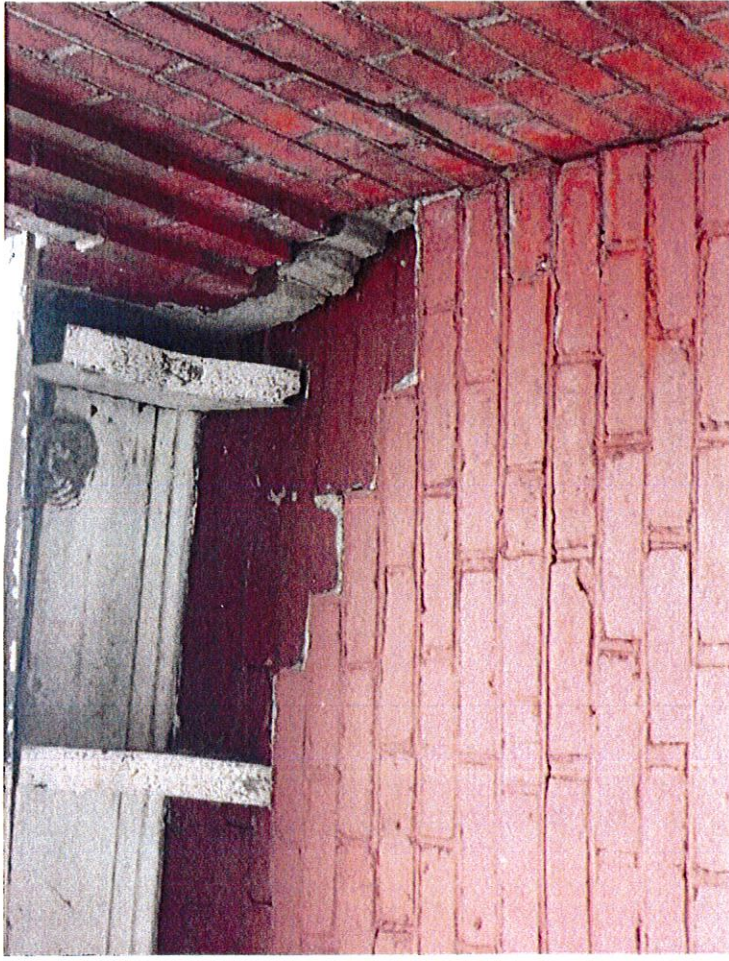
Damaged brick walls

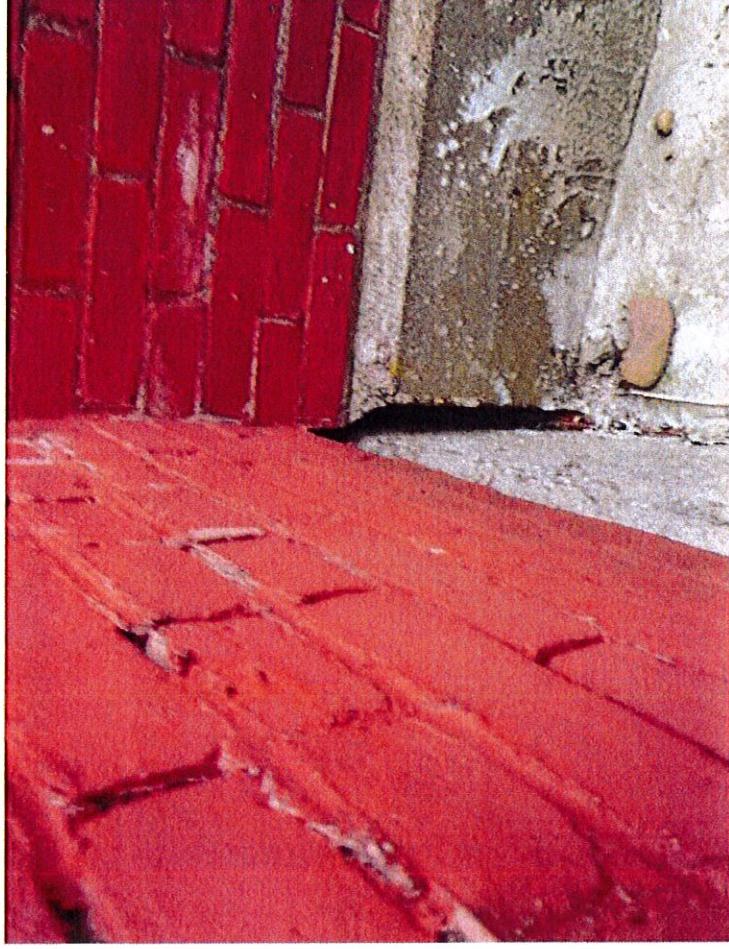
Settling foundation

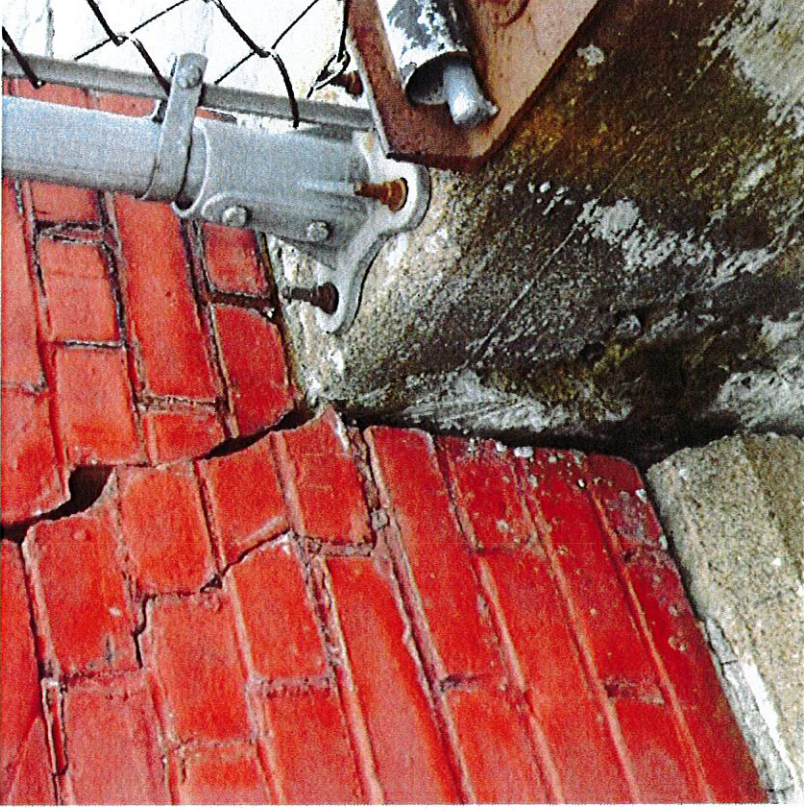
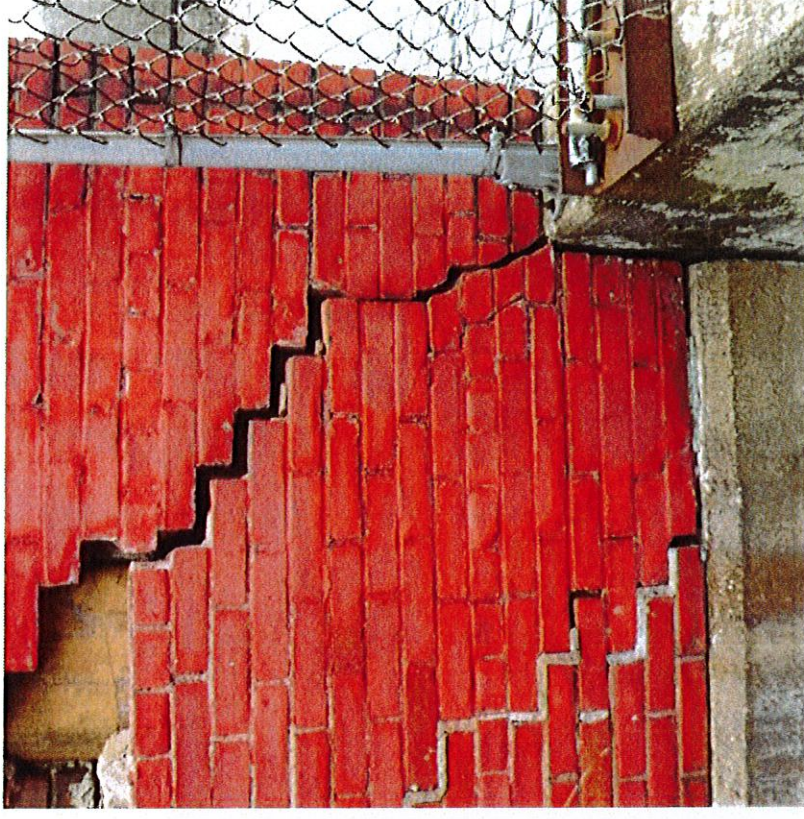
- 2) The addition, which was added at a later time, and has experienced settlement at the NW corner. This has caused the North wall of the addition to pull away from the main building on the NE corner at the top. Also, we estimate that the crack in the face of the West wall at the SW corner was also caused by the settlement at the NW corner. It is our opinion that this does make the newer building more open to the elements, and if the settlement in the NW corner continues to any significant degree, this could cause the North wall of the addition to pull away even more from the original building, creating an unsafe condition. It would also cause the crack in the SW corner of the building to increase in size.

Brick damaged by settling foundation

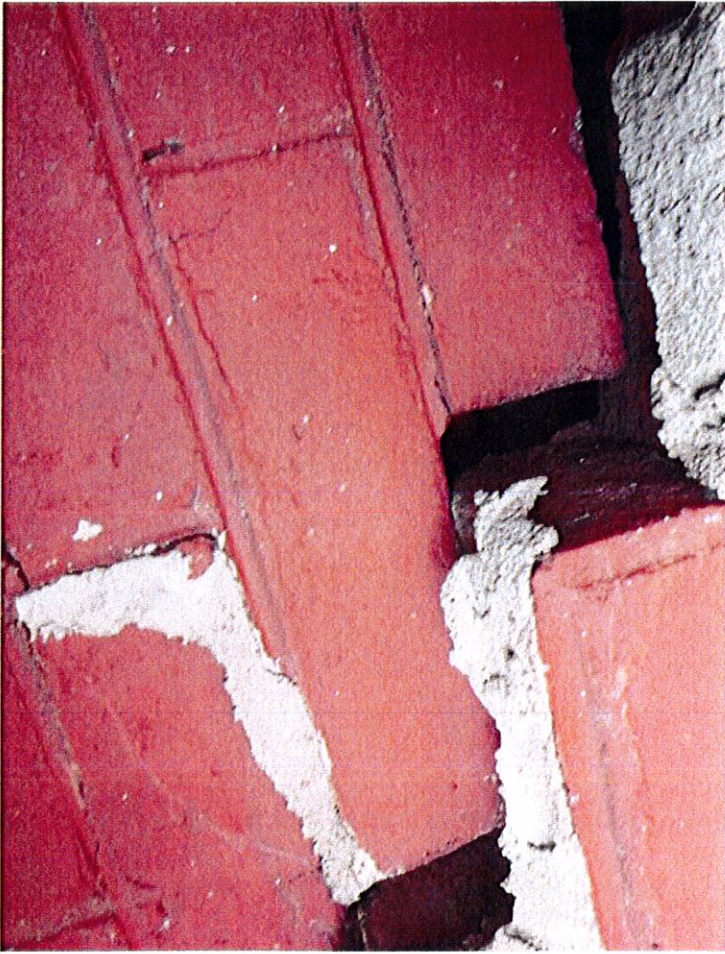
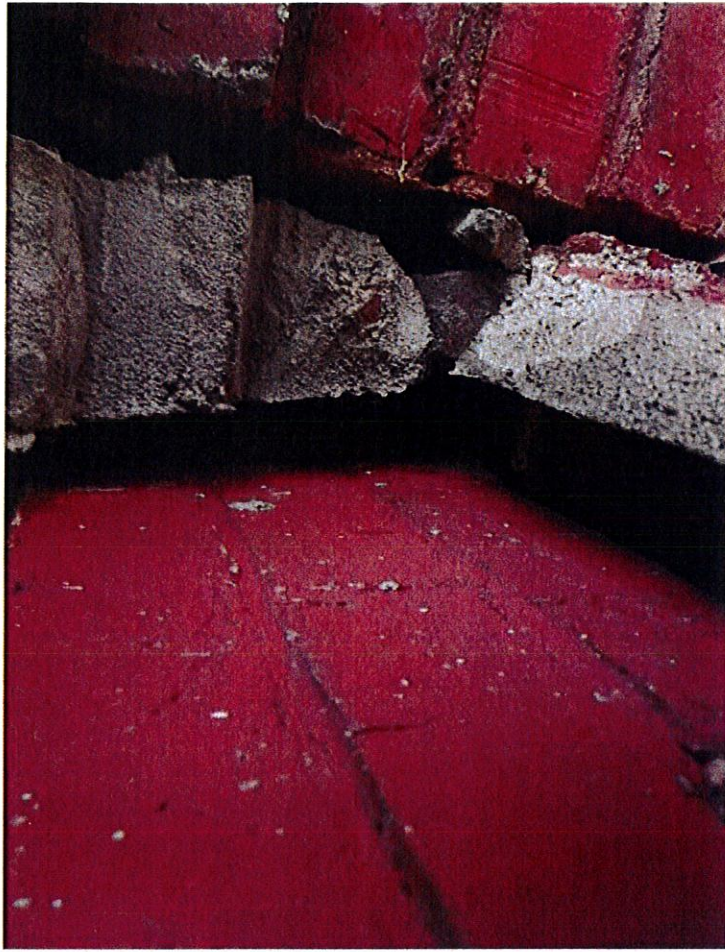
Brick damaged by settling foundation

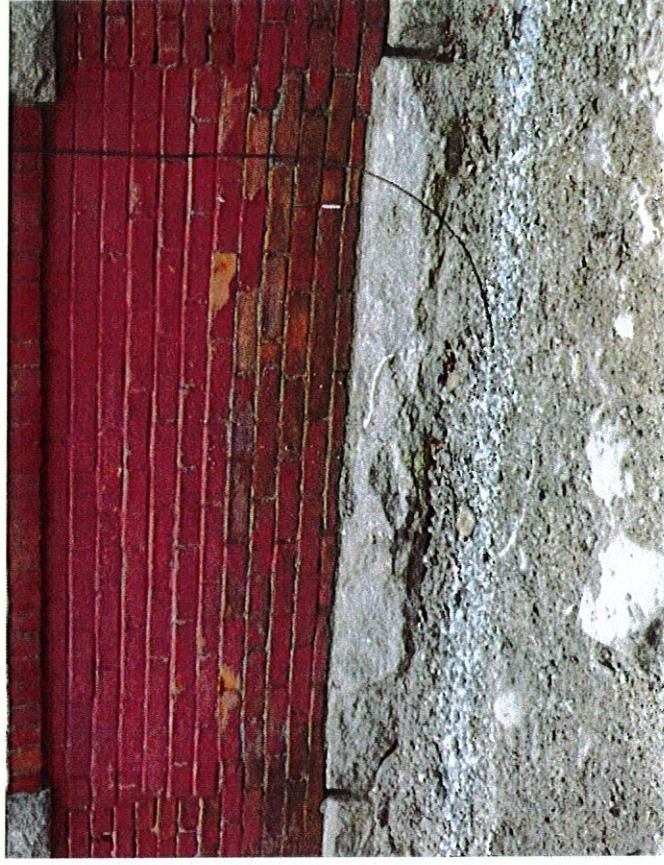
Settling Foundation

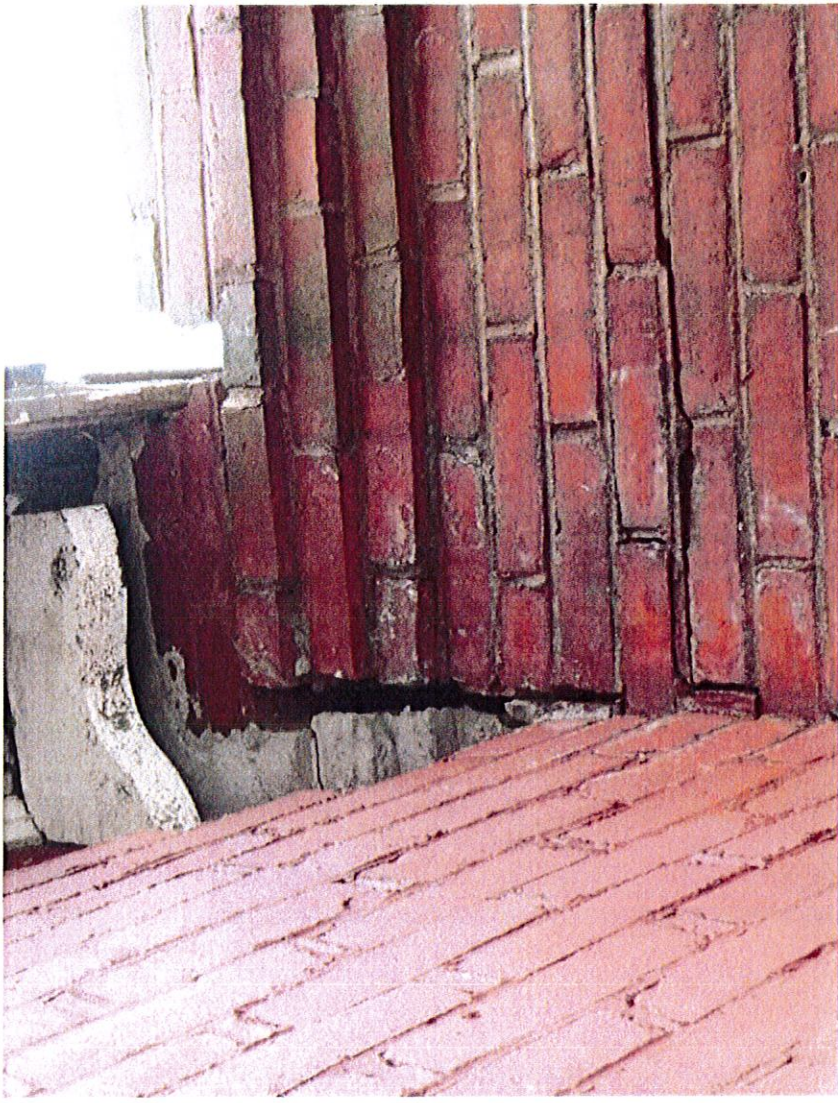
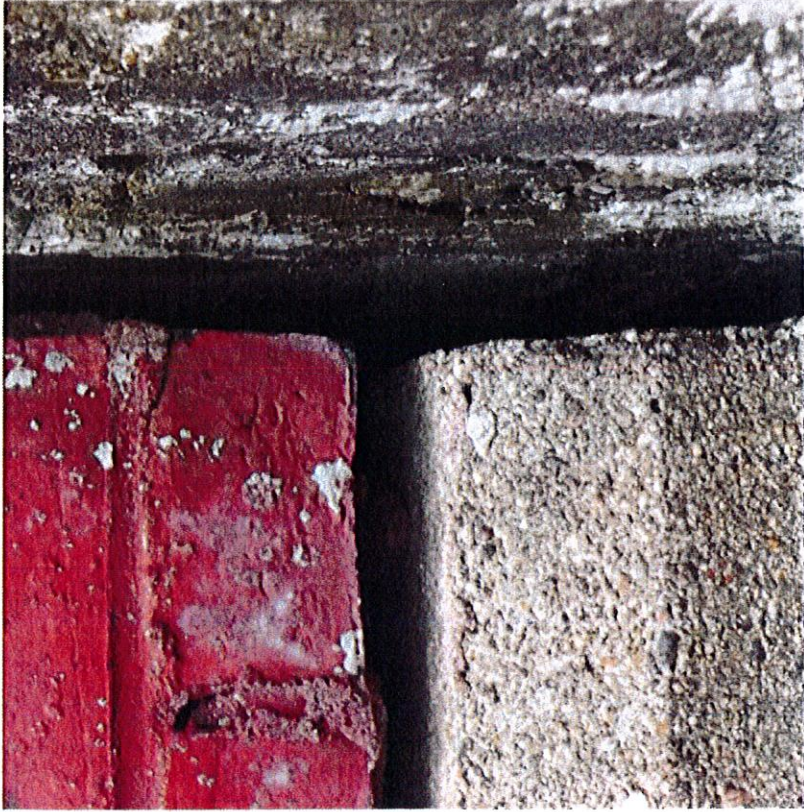
Cracks due to settling foundation

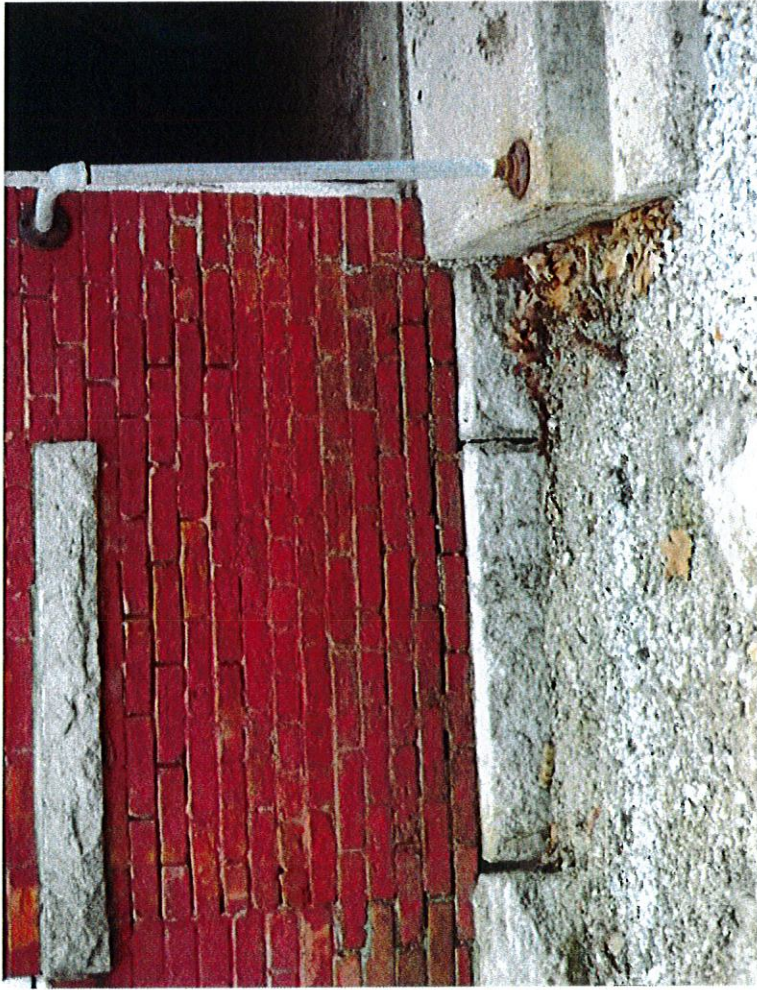
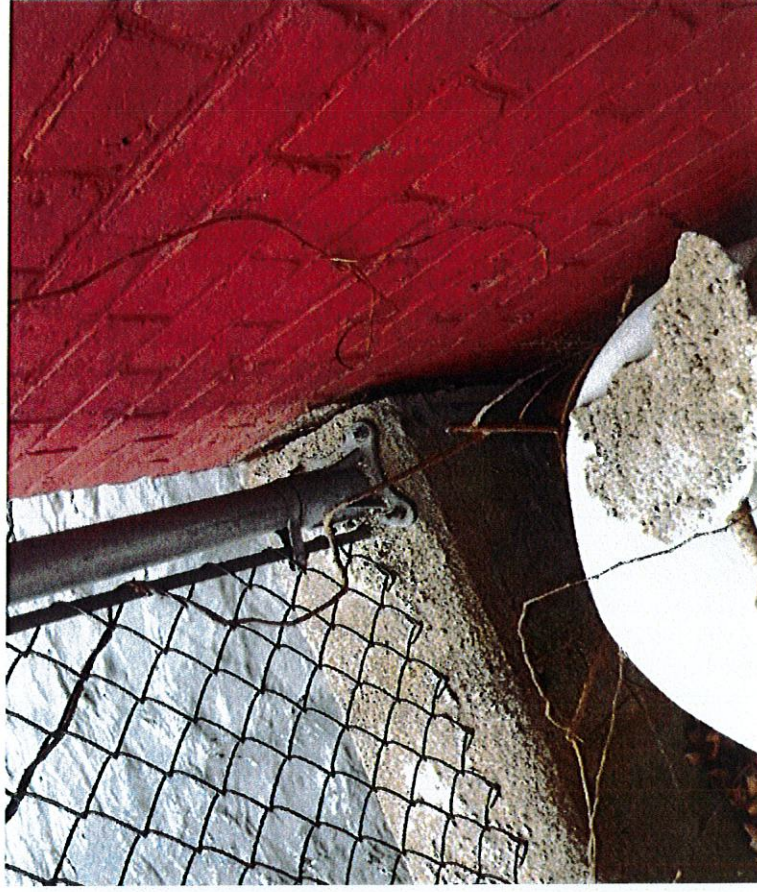
Settling foundation blocks

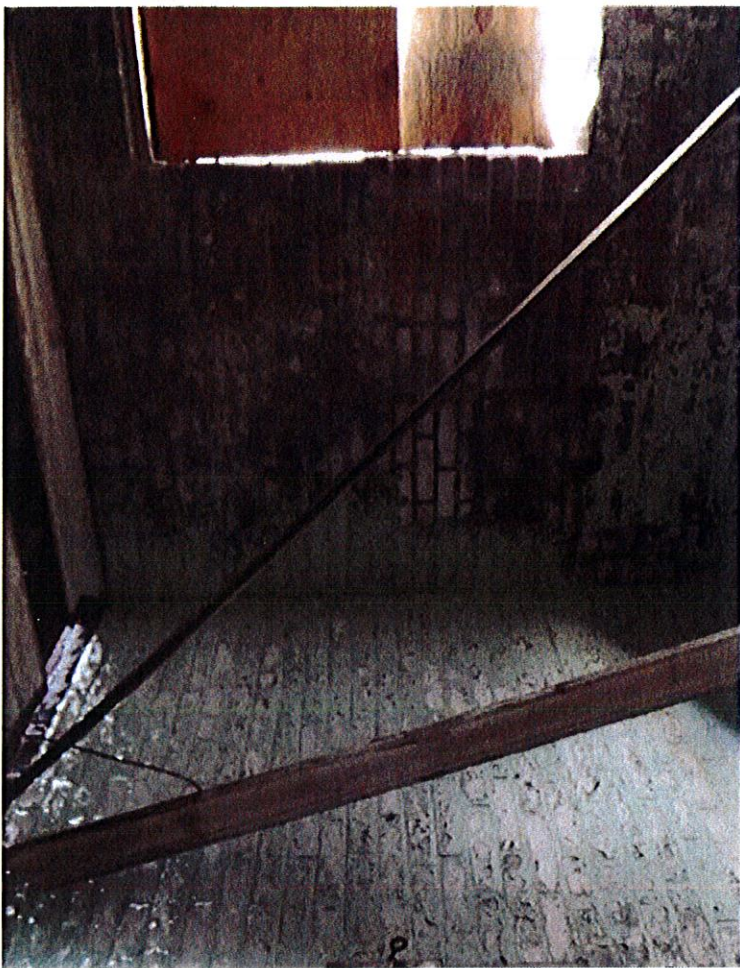
2. The main building shell is made of brick approximately 12 inches thick. The only access door is at the street side of the building (called North). Windows exist in the South, East and North walls, but the glass has been broken due to vandalism. The windows are now covered in plywood.

Broken windows

- 2) Maintain the plywood in the windows, but seal around them to eliminate any large cracks and maintain water tightness.
- 3) Clean up broken glass and other debris that is located in the older section of the building to minimize any potential injuries when accessing the building.

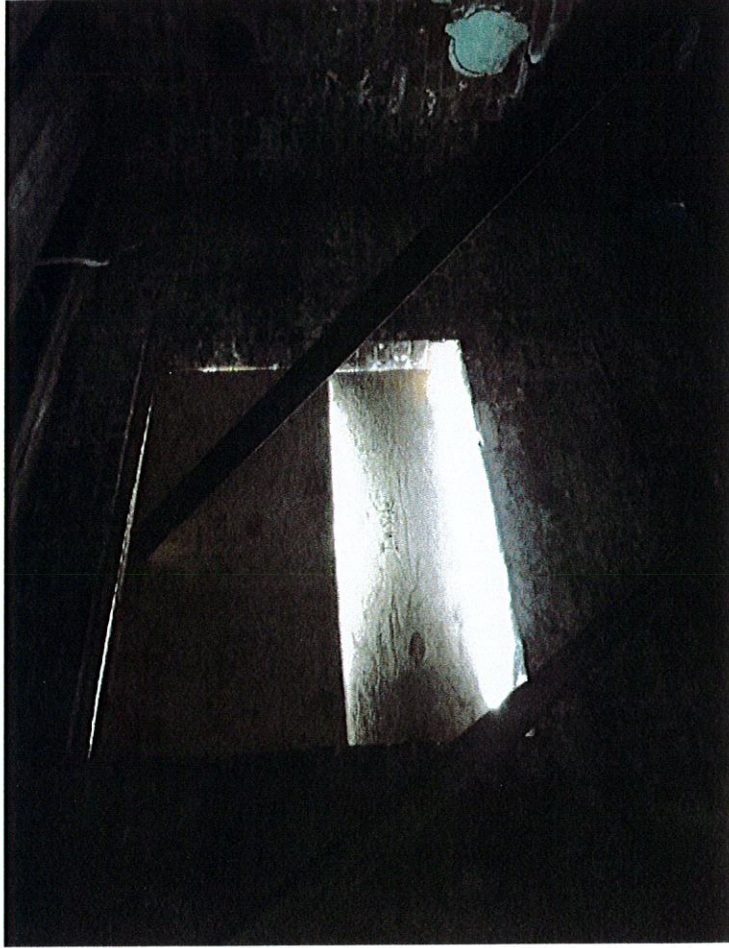
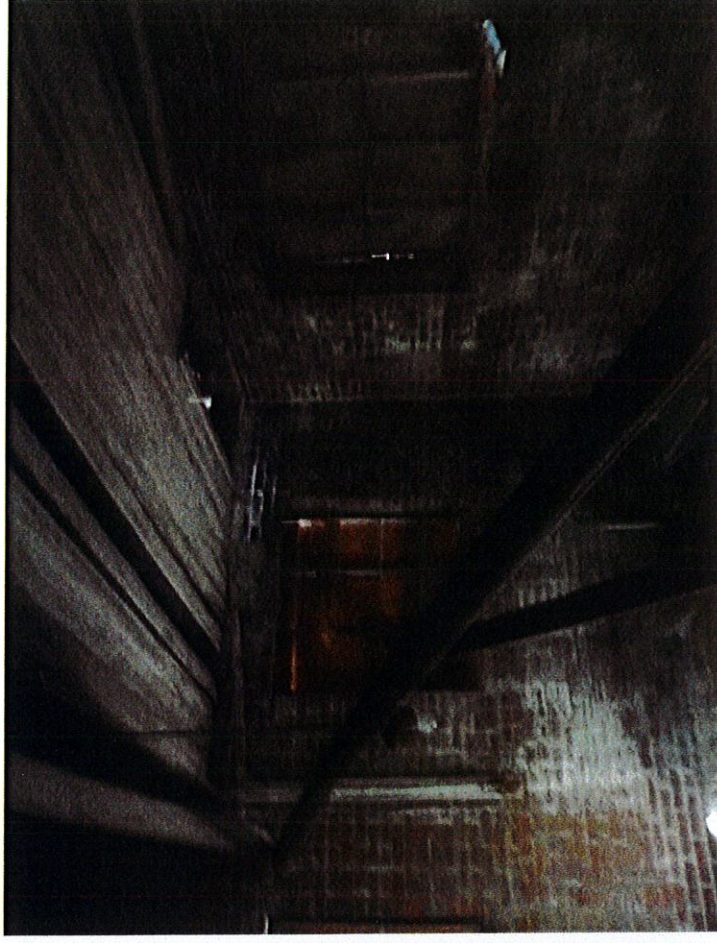
Interior view with broken windows and damaged ceiling

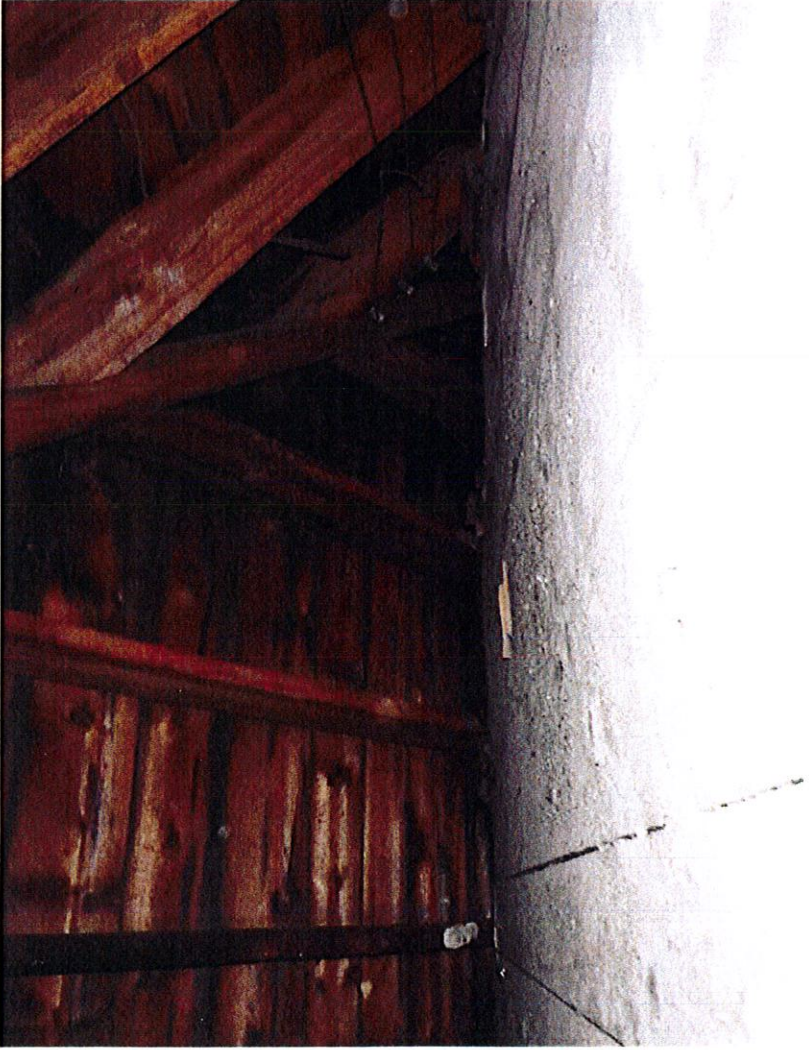
Attic of eastern structure
