## Conditions Assessment & Feasibility Study

Franklin City Hall & Opera House  
Franklin, NH

**March 22, 2024**

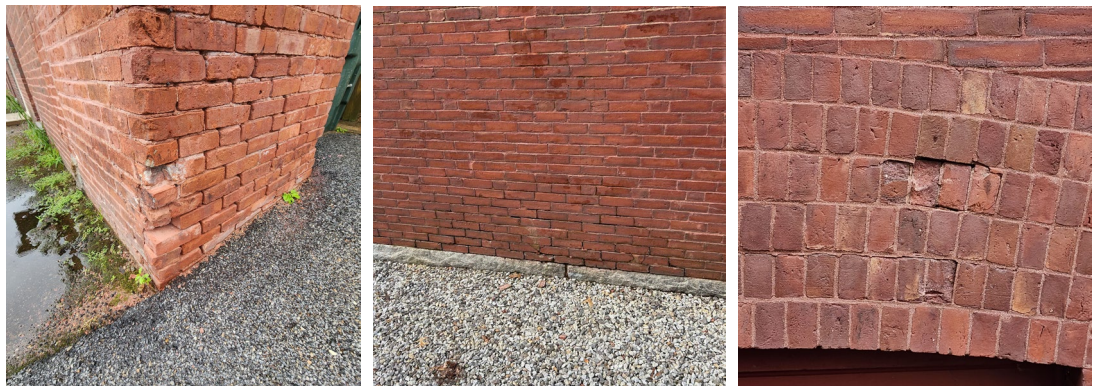
1. Brick is crumbling in multiple areas, there are cracks in some parts of the mortar and will need localized repointing and repair.

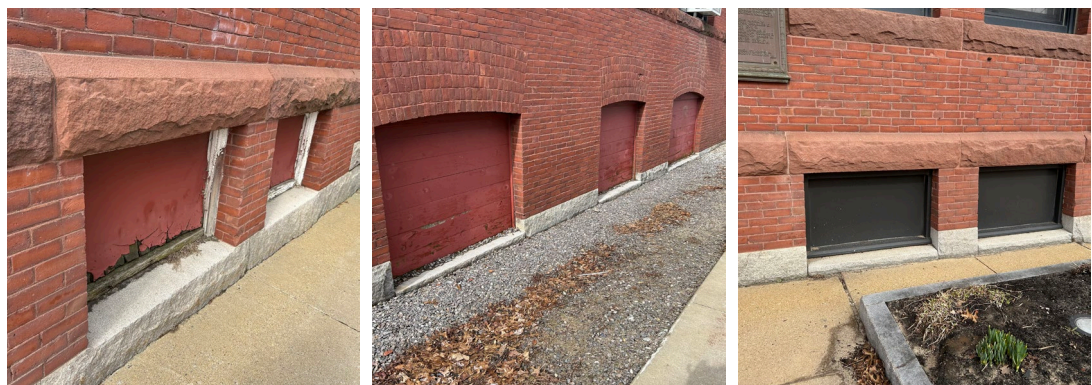
2. Basement windows have been boarded up on the street side, windows should be replaced in the same place to allow for more daylighting in the basement.

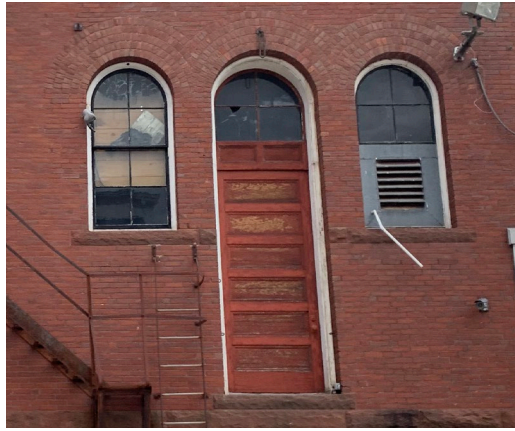
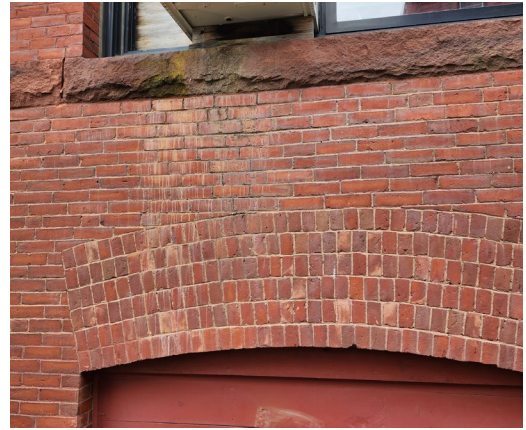
3. There are windows where the glass is cracked or damaged and will need to be repaired. The window sills are mostly in good condition though there a few that will need further investigation, specifically under the window AC units where water damage has occurred.

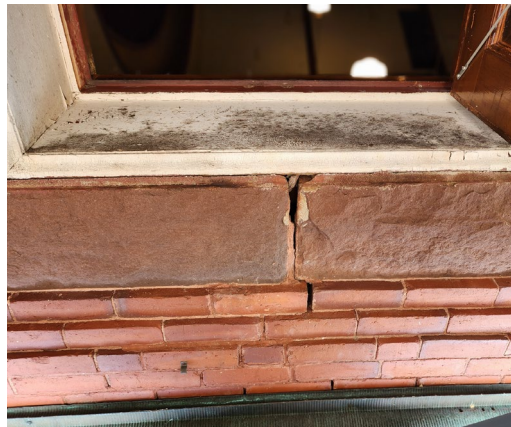
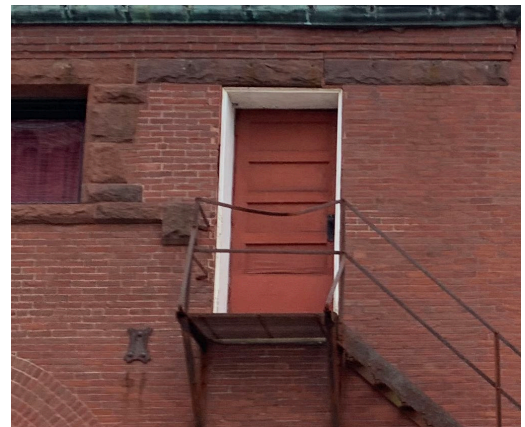
4. The brownstone masonry headers are cracked or deteriorated above the exterior doors in multiple locations, repair or replace as needed, specifically at the mezzanine exit doors on both sides. There is mold and mildew growing on the threshold above the doors that will need to be cleaned. All exterior door flashing should be investigated and reflashed.

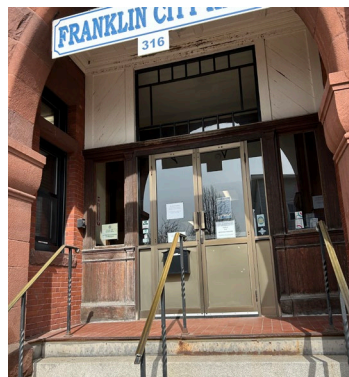
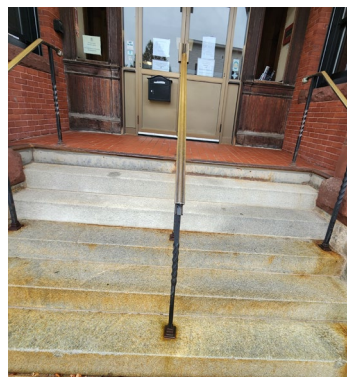
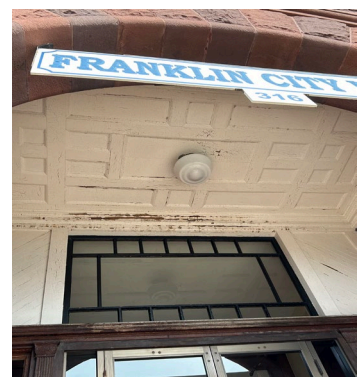
5. Repair moisture damage at front entry and repair or replace the wood where decayed. The front entry railings should be repaired and repainted. The landing currently does not meet ADA standards as the primary means of entry. However, it does meet life safety code. (Note: and ADA compliant entry added to another side of the building could potentially eliminate the need to reconfigure this main entry to comply with ADA standards.)

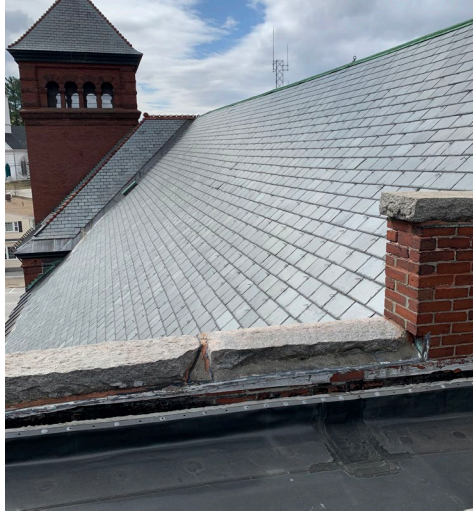
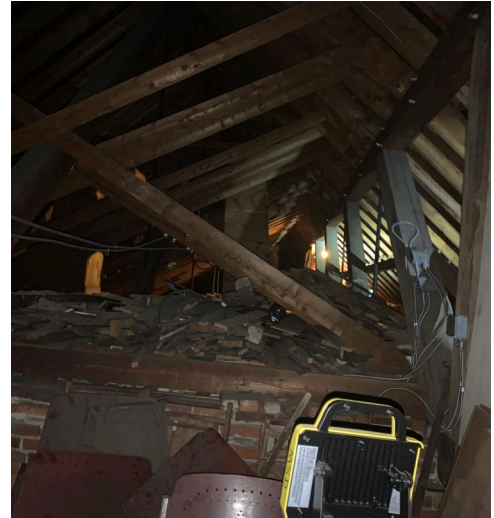
6. Slate roofing and flashing is nearing the end of life expectancy. There is evidence of moisture damage to the opera house ceiling facing the street where the flashing should be investigated thoroughly

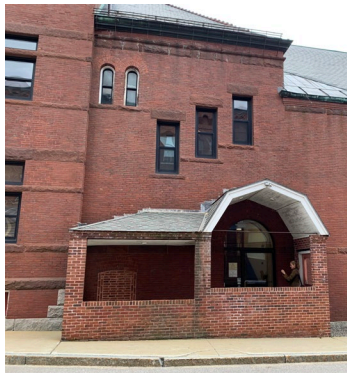
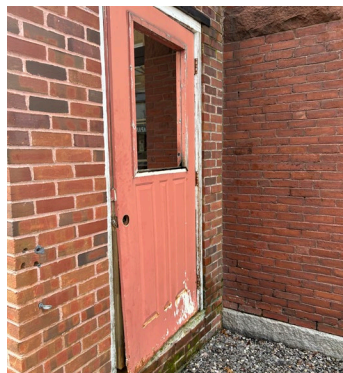
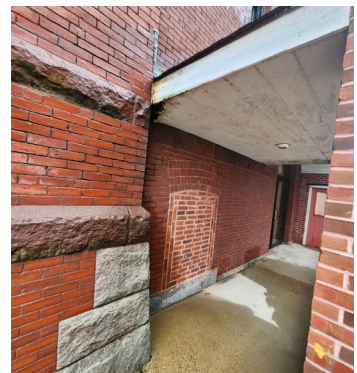
7. The existing side porch addition for ADA access is in severe disrepair. There is moisture damage to the roof, brick doors, and trim. The roof assembly will need to be replaced or demolished

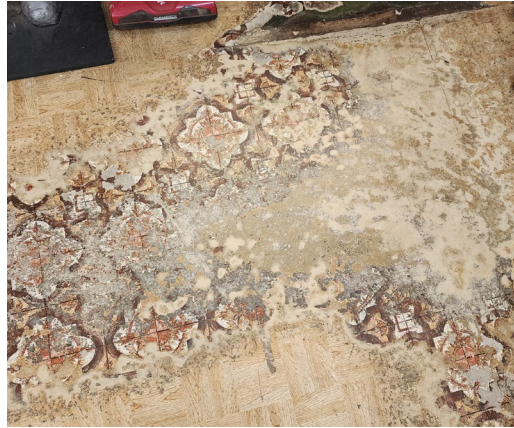
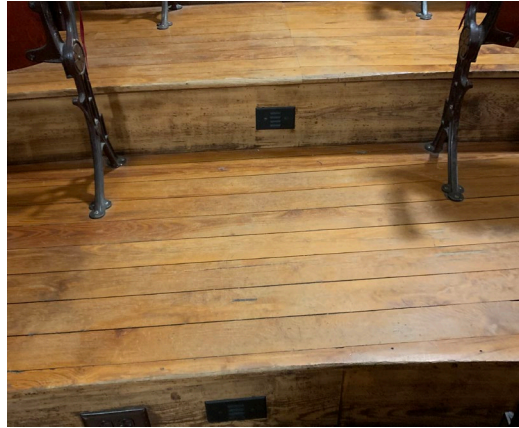
1. Fix creaky flooring that is typical throughout the building with focus in the opera house, secure any loose boards, & verify localized needs for reinforced substrates. Wood flooring finishes are worn and in need of repair and repaint. Acoustic insulation to floor ceiling assembly between theatre & city offices is needed for noise isolation between city hall and theatre use.

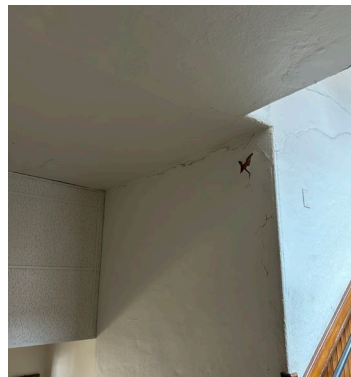
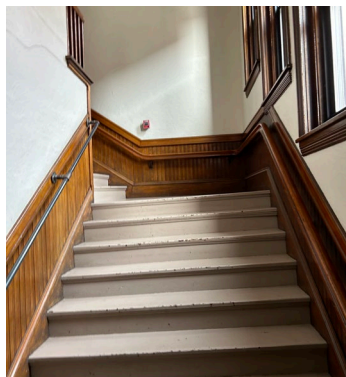
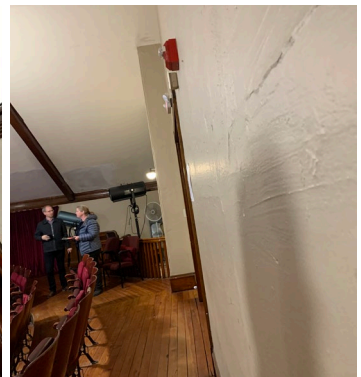
2. Drywall is worn and damaged in most areas of the interior. Plaster on lathe is in need of repair in various parts of the building. The decorative wood trim should be repaired or replaced where needed.

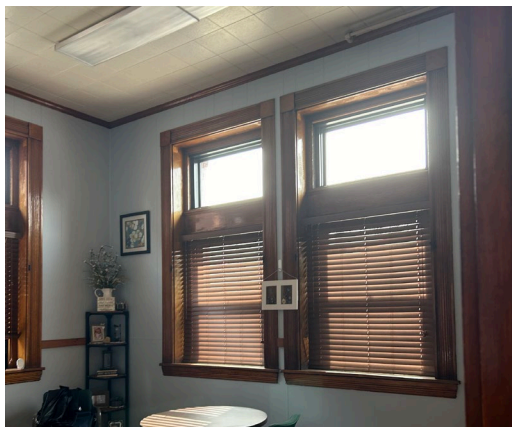
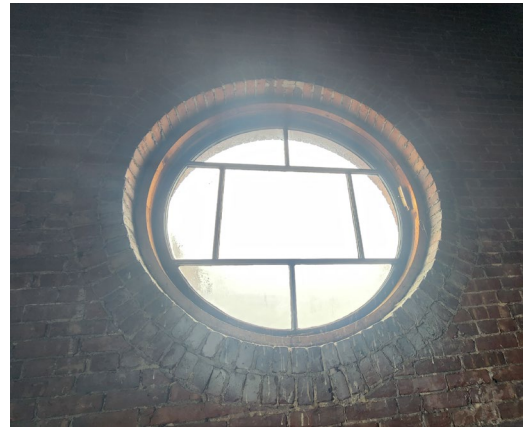
3. The finish of interior jambs, sills, & window flashing or sealant is in need of repair throughout the building.

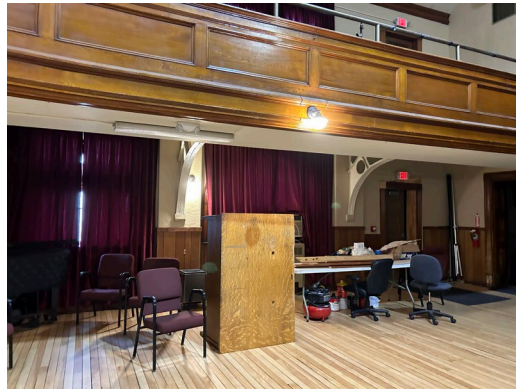
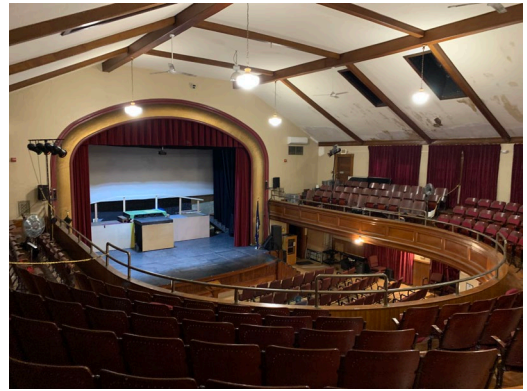
4. All railings should be made code compliant especially those in the mezzanine of the opera house.

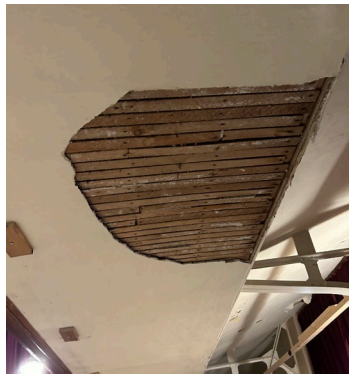
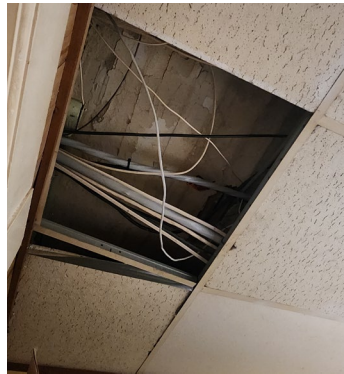
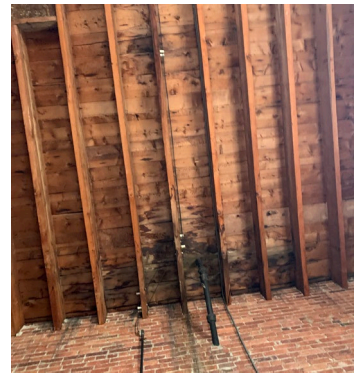
5. Repair, patch, & repaint holes in walls and ceilings throughout the building. There is evidence of moisture damage in various parts of the ceiling that are in need of repair.

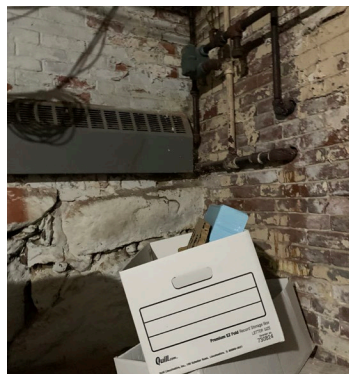
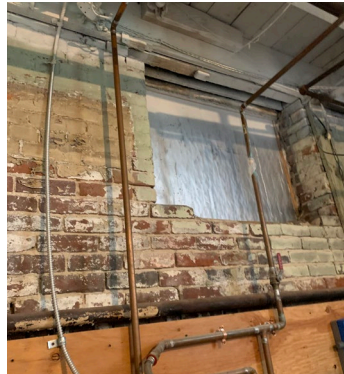
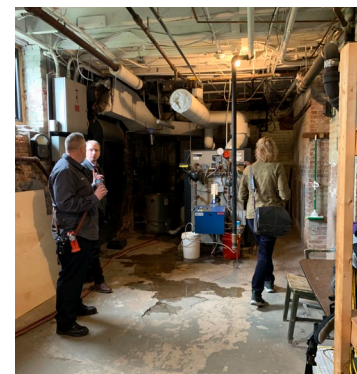
6. Basement is damp and musty. There is cracking and spalling at masonry mortar joints due to moisture and vapor infiltration. The bricks along the exterior wall in the mechanical room have deteriorated severely. Various holes in masonry walls at utility penetrations are allowing additional moisture and thermal infiltration. The built up wood flooring should be removed and replaced with concrete slab on grade assembly. The column bases throughout the basement should be investigated at the foundation for moisture damage.

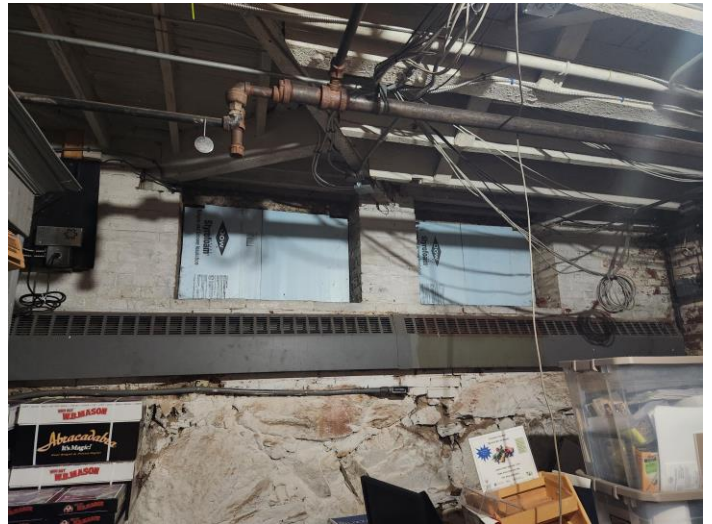
**Typical Fin tube in storage areas of basement and  
uninsulated hot water piping**

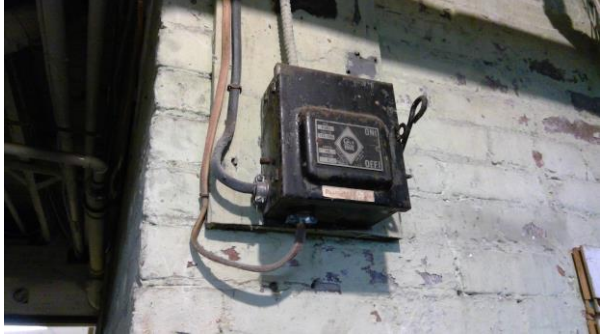
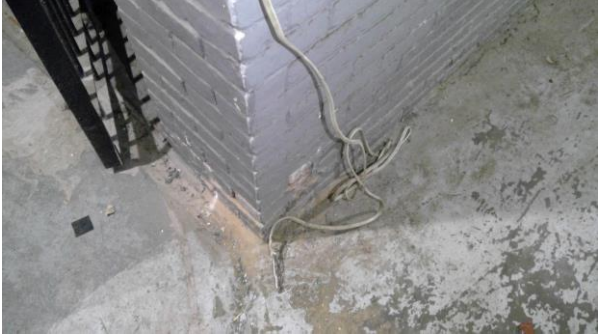
<b>Electrical Disconnect Switch</b>		<b>Abandoned Romex Conductor</b>
