Trestle Bridge Presentation – October 11, 2022

Description of Bridge

Structural Inspection Findings

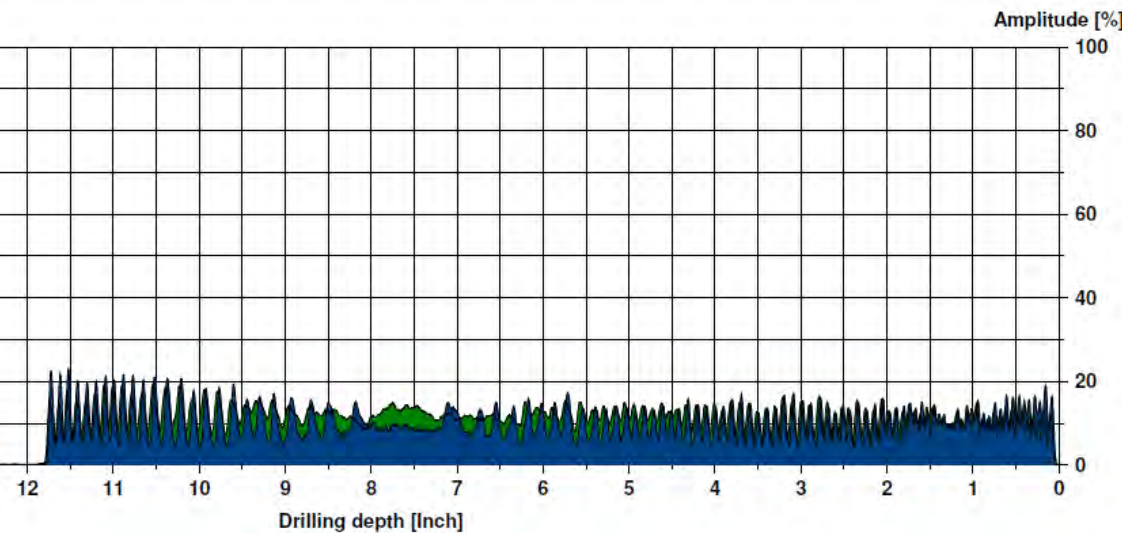
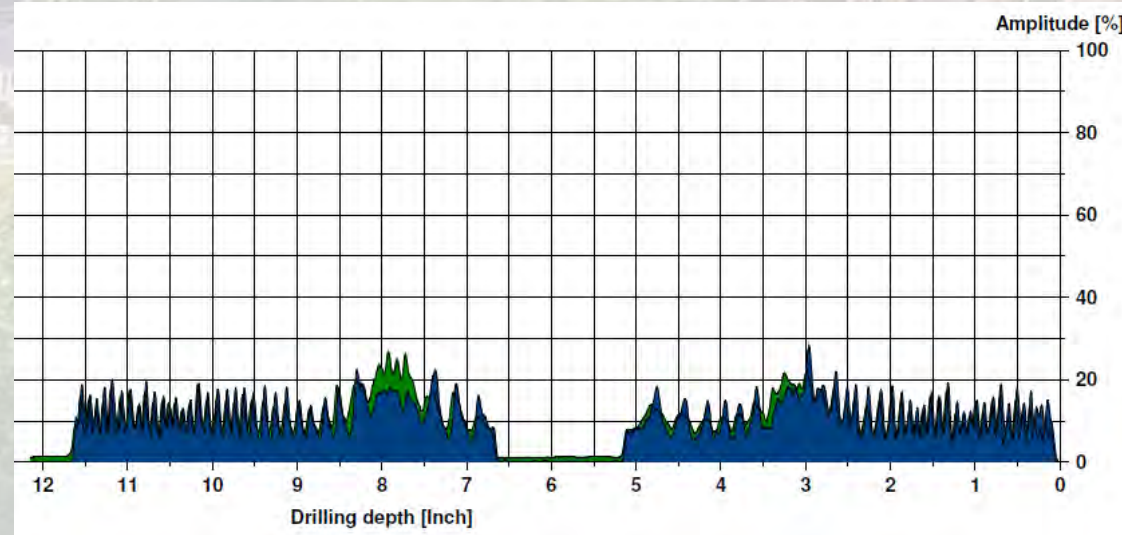
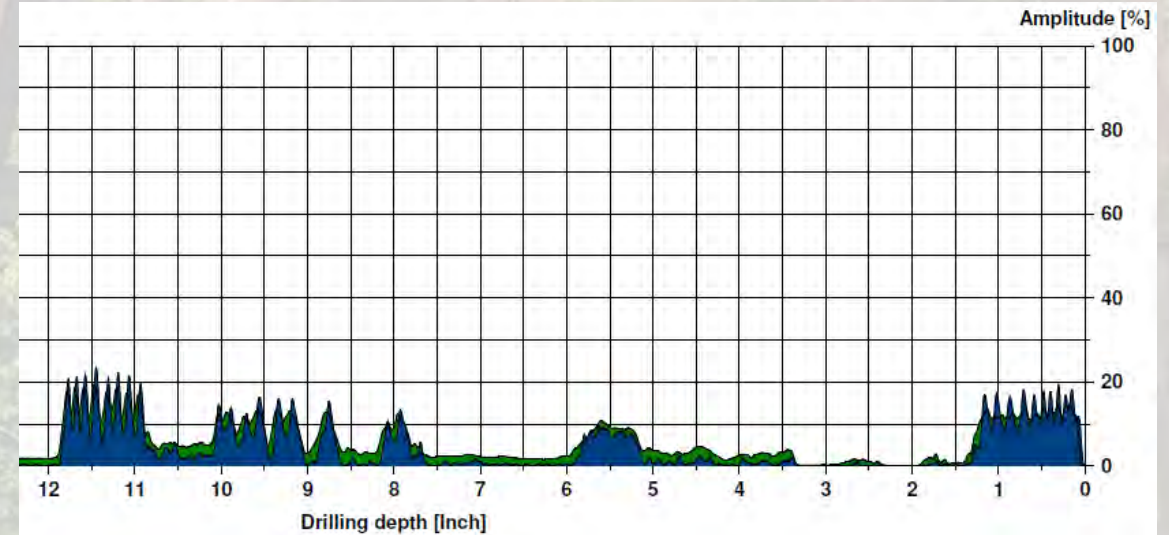
SAMPLE DRILL RESULTS

- Note the drilled dimension is 11.75" in all members
- Top Left – Quality wood, no obvious signs of defects
- Bottom Left – Majority is OK, but middle 1.5" is rotted
- Bottom Right – The exterior 1" on each side is ok, but rest of section is deteriorated

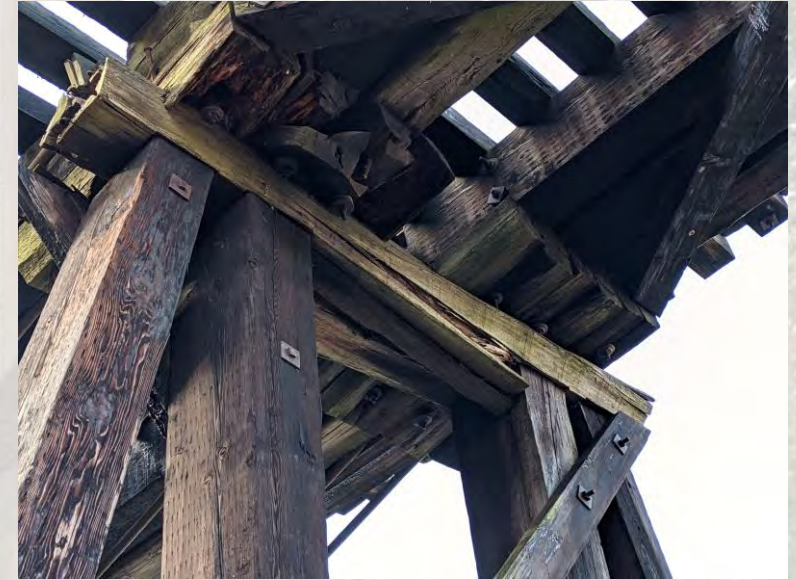
BENT 13

Bent 13	CR	RE, HO, DT (6')	RE, HO, DT (6')	RE, HO, DT (6')	RE, HO, DT (3')	Bolsters are crushed.
Bent 14	CR	RE, DB	RE, DB	RE, DB, SD	RE, DB	Bolsters are crushed. C2 and C3 are doubled/twin columns (each).
