RE: Stevens Mill, 20 Canal Street, Heritage Commission Review.

<u>ATTACHMENT [2]</u> HISTORICAL NARRATIVE

HISTORIC PRESERVATION CERTIFICATION APPLICATIONS PART 1

ATTACHMENT [3] NPS DRAWINGS

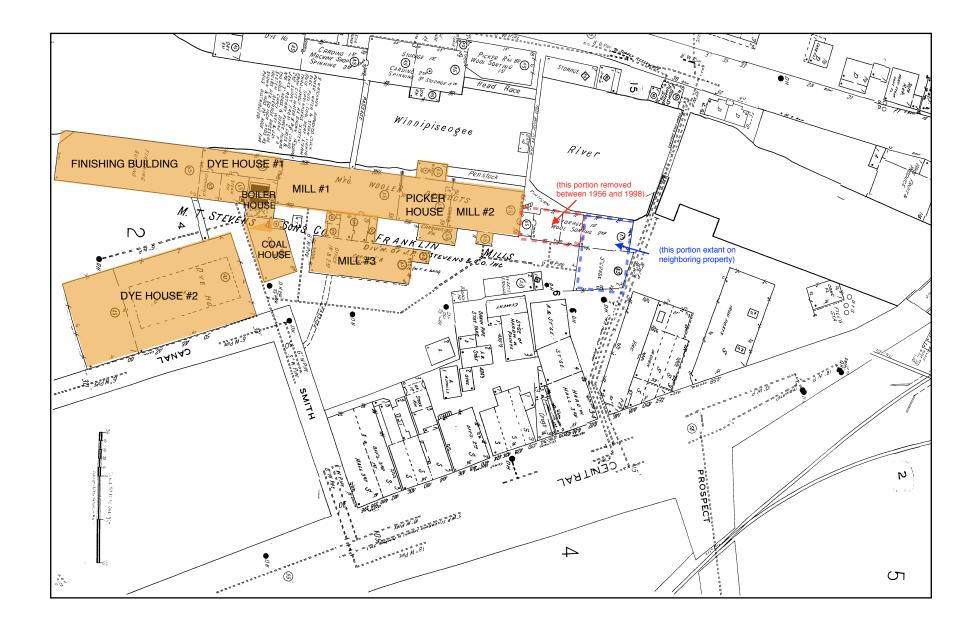
1943 SANBORN INSURANCE MAP

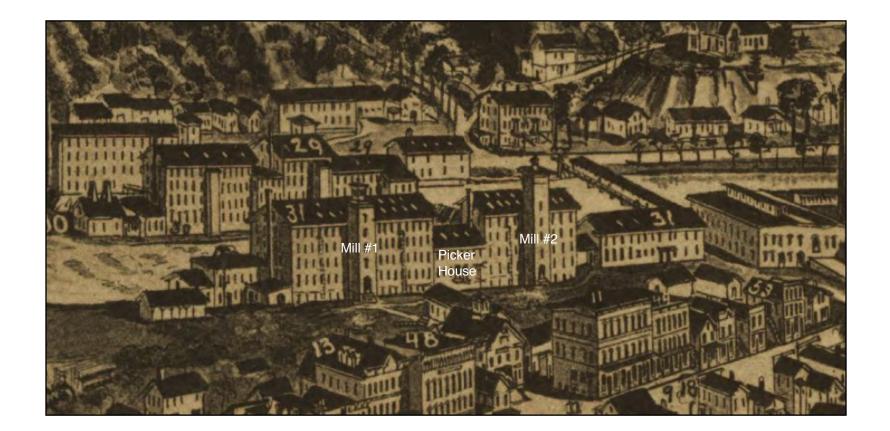
1884 BIRDS EYE VIEW

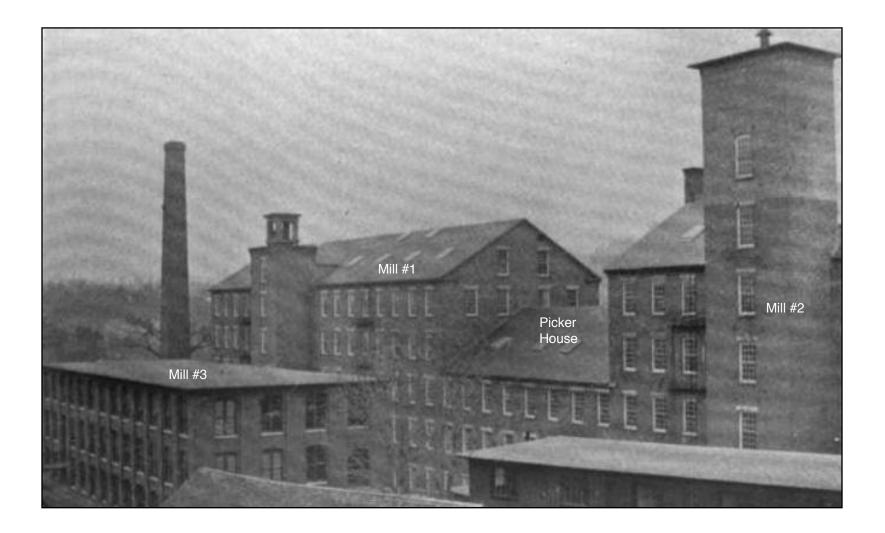
ca. 1895 VIEW showing mill buildings before gable roofs were removed and a floor was added

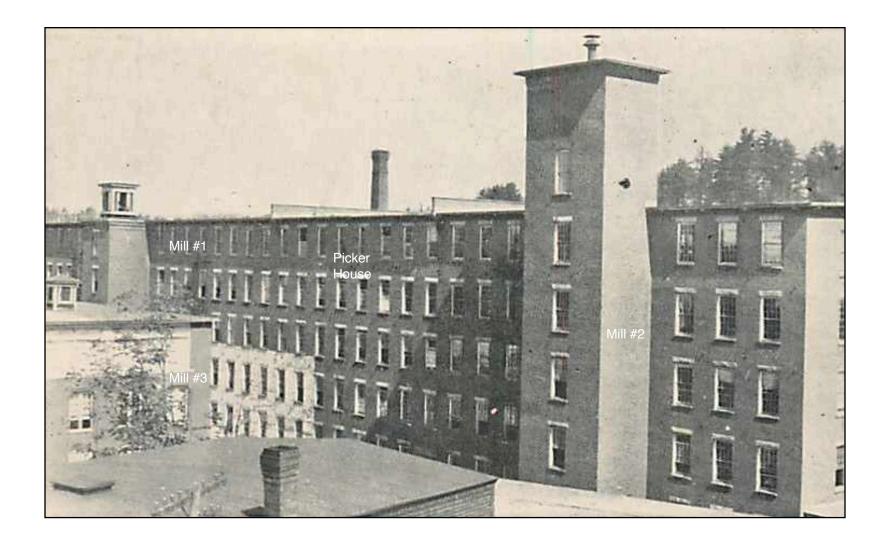
MID-20th CENTURY VIEW showing mill after the top floors were added to the mill buildings (between 1892 and 1904)

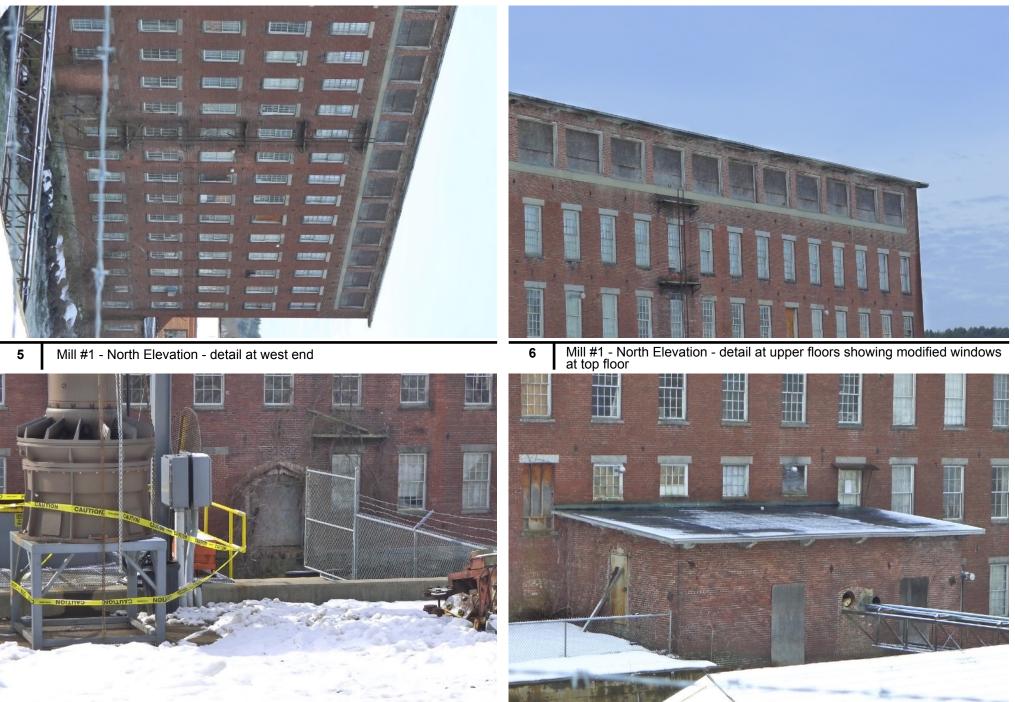
Mill #1 - North Elevation - detail at lower level showing modified window openings 8

Picker House - North Elevation - detail of ca. 1895 wheel house addition

- One window at the lower level of the north elevation was converted to a doorway (Photo 7).
- An early metal fire ladder remains at the north elevation (Photo 6).

- A one-story brick wheel house was added to the north elevation between 1892 and 1897 (Photo 8).
- A one-story addition was constructed across the eastern half of the south elevation in the late 19th century; the addition was heavily altered in more recent years, so that no historic fabric is evident on the exterior (Photo 47).

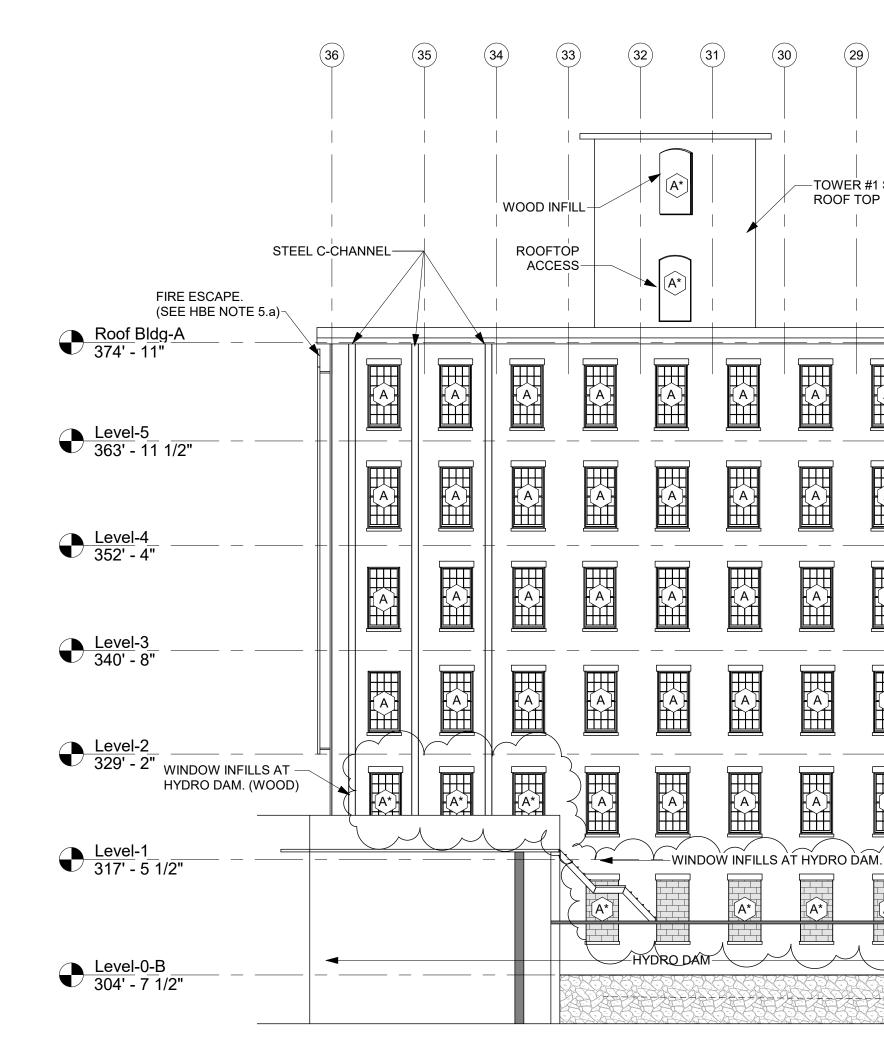
1 NP-Bldg A North Elevation 3/32" = 1'-0"

) (:	28 (2	7) (26 (2	25) (2	24) (2	23) (2	22) (2	1) (2	0 (19	9 (18)	(.			5 (1		
#1 STAIR OP ACCE	ss				DR OVER RU TO BE RE F											
	FIRE WALL-		 	 		 					FIRE	 WALL 	 		 	FIRE ESC REMAIN. (SEE HBE
								G								
AM. (MASC)

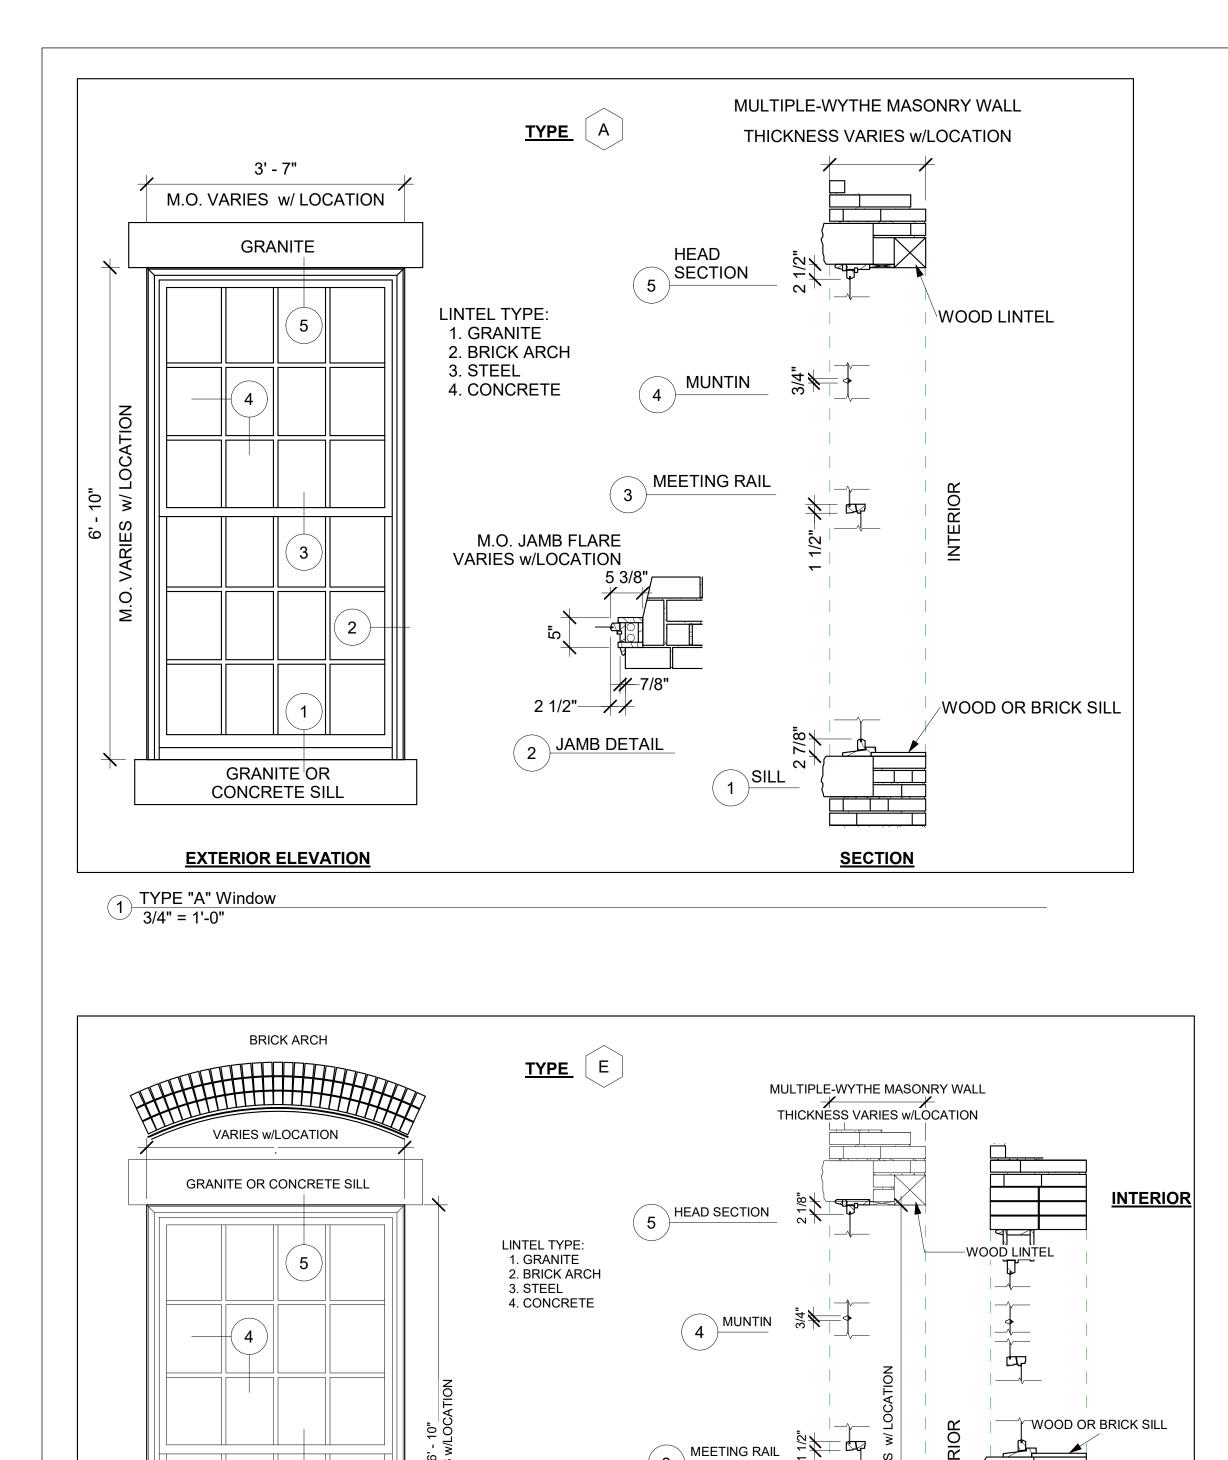
2 JAMB DETAIL

M.O. JAMB FLARE VARIES w/LOCATION

GRANITE OR CONCRETE SILL
