Trestle Bridge Presentation – October 11, 2022

Description of Bridge

Structural Inspection Findings

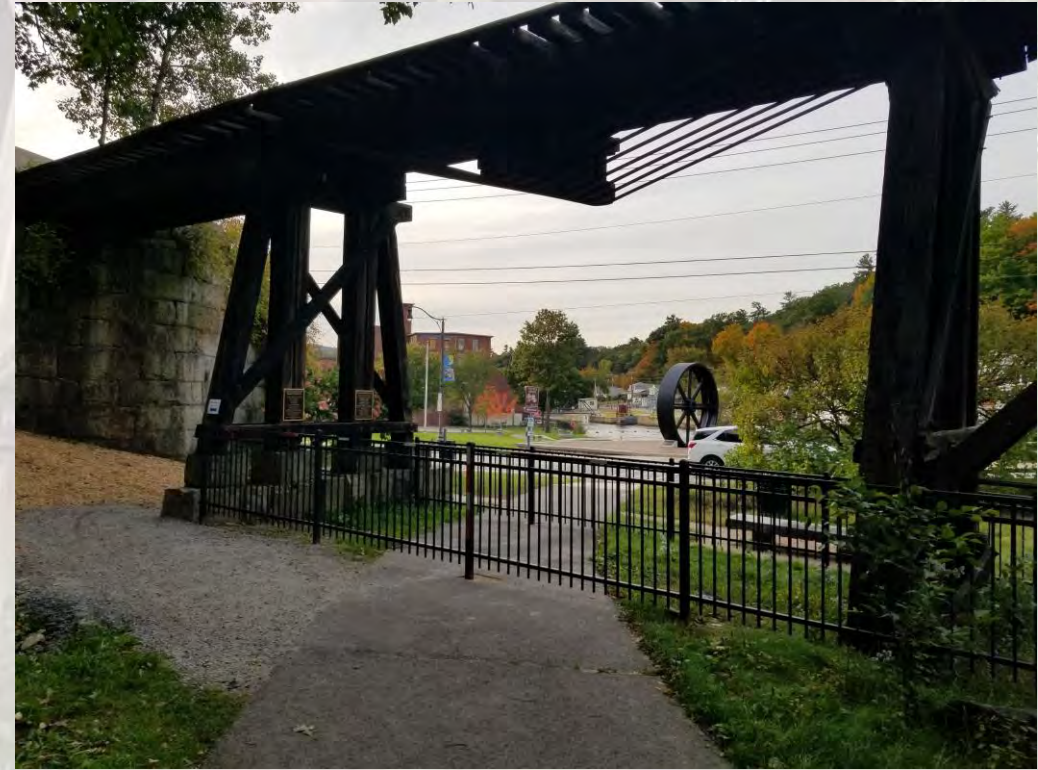
- Portions of the Truss are in Poor Condition
- Truss is Continuing to Deteriorate
- 2019 Inspection Led to Path Relocation
