## Conditions Assessment & Feasibility Study

Franklin City Hall & Opera House  
Franklin, NH

**March 22, 2024**

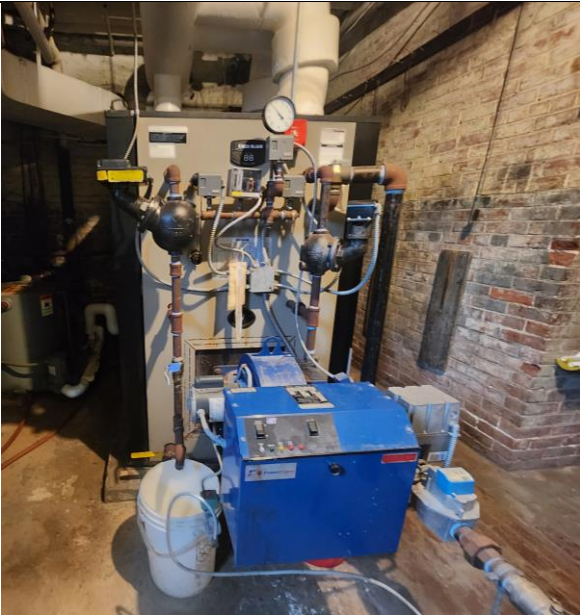
**Weil McLain Boiler and Power Flame Burner**

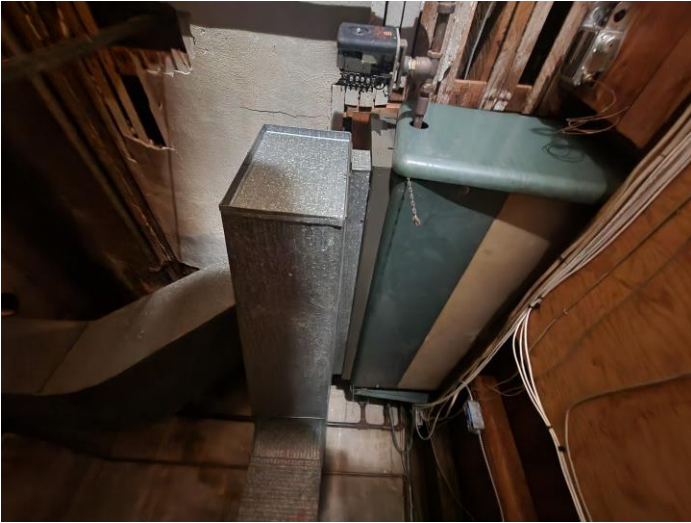
**Hot water fan coil unit**

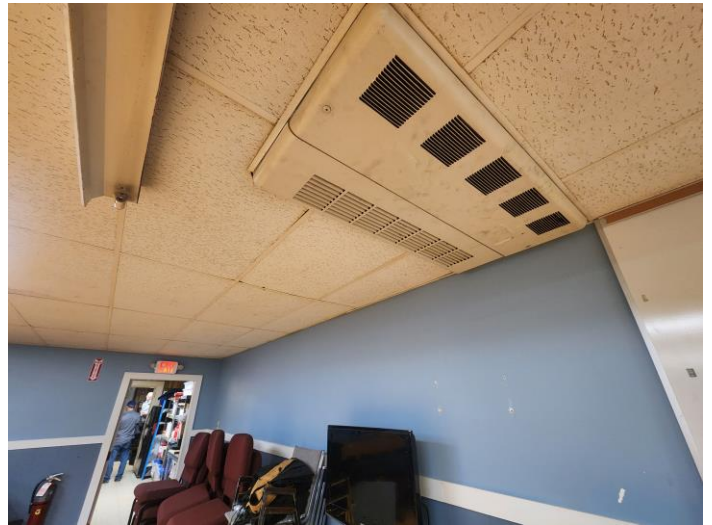
**Hot water cabinet unit heaters**

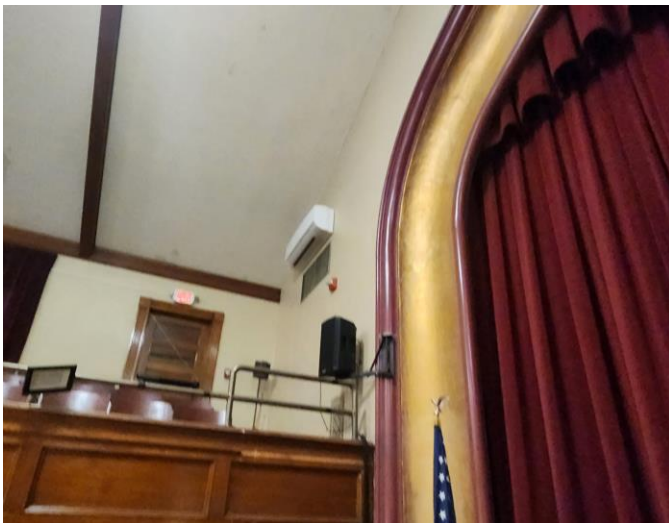
**Auditorium Cooling and fresh air supply grille**

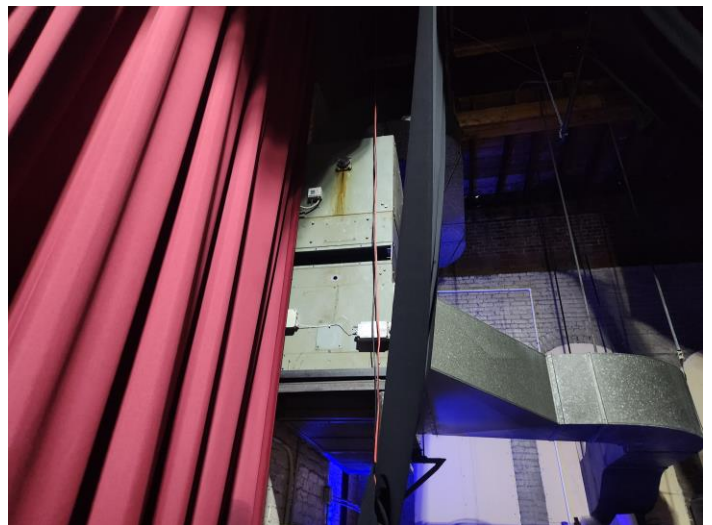
**Typical Auditorium air handler**

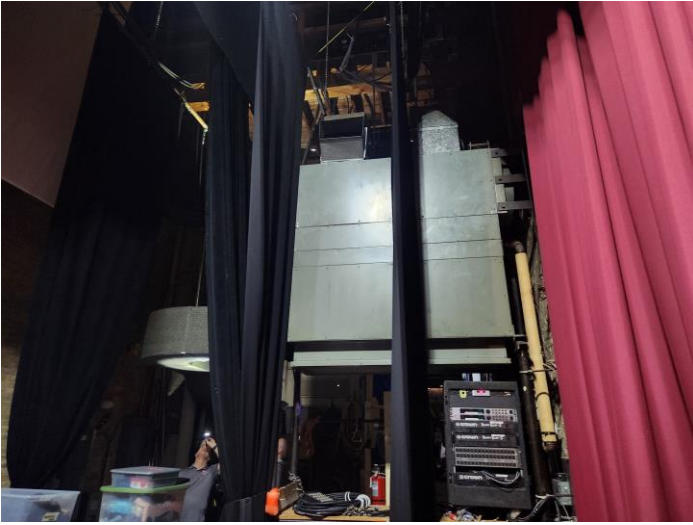
**Auditorium air handler**

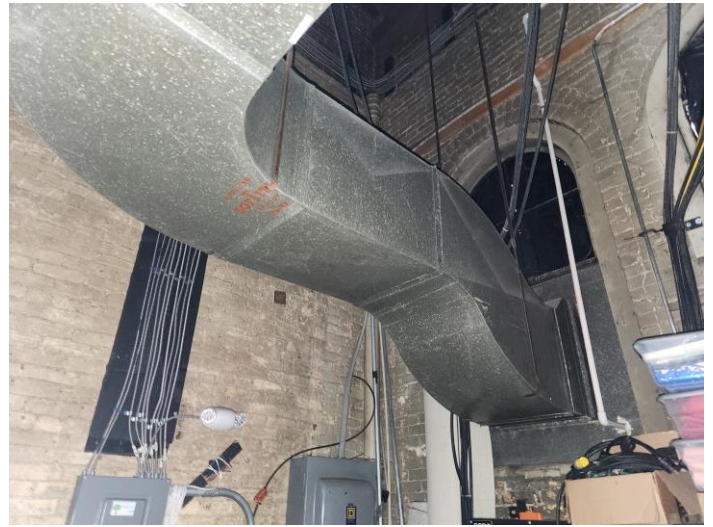
**Auditorium AHU fresh air connection above door**

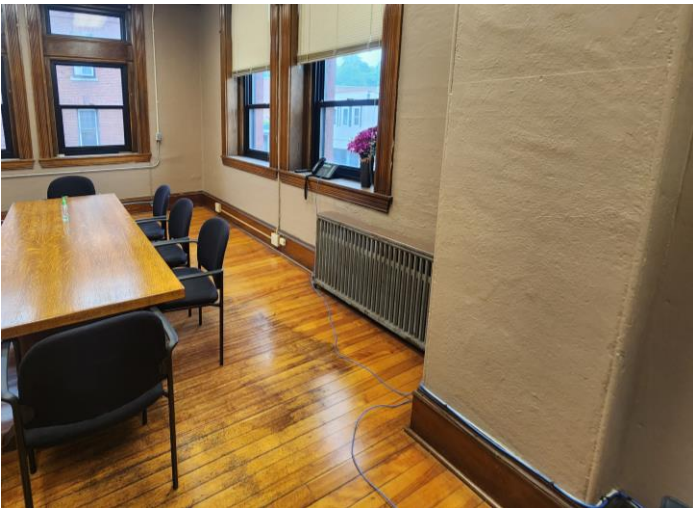
**Typical Steam Radiator**

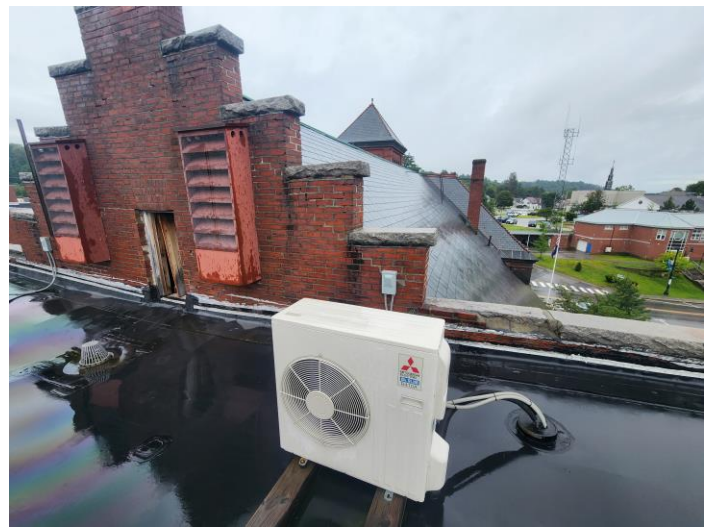
**Auditorium condensing units on roof**

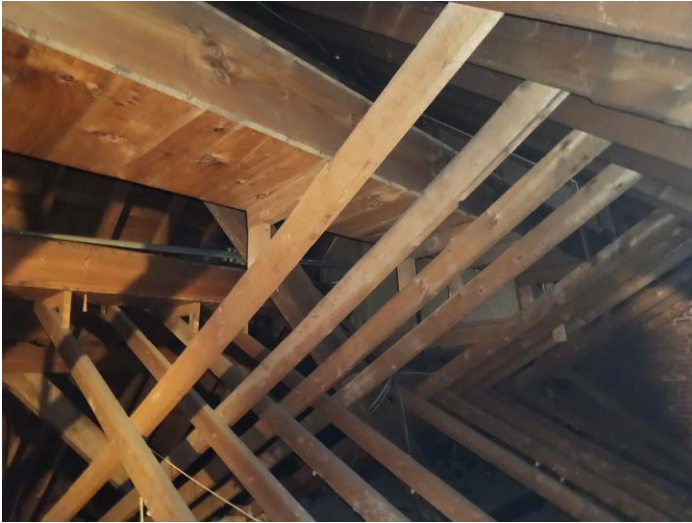
**Wooden Relief ductwork in attic**

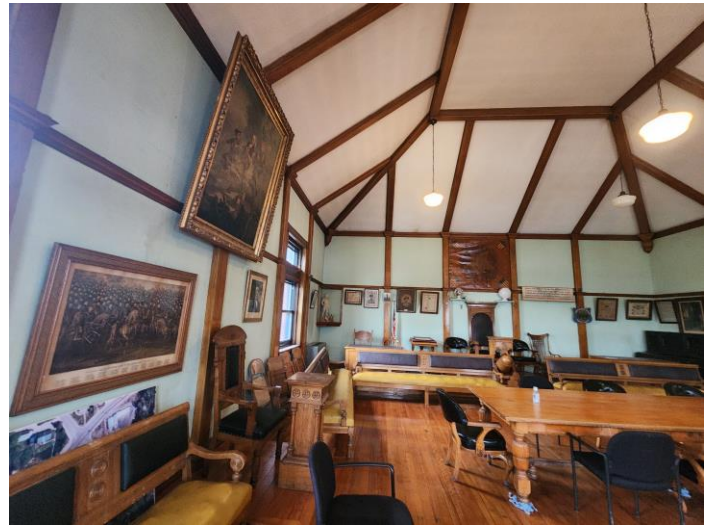
**No cooling or air provided in 2<sup>nd</sup> floor meeting room**

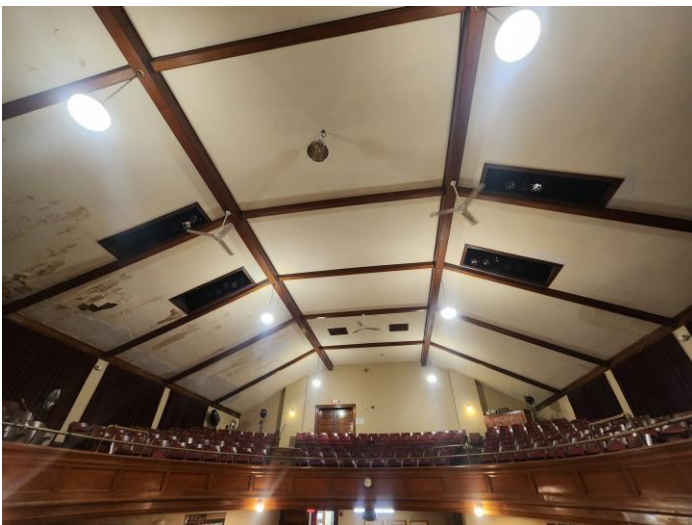
**Auditorium ceiling with destratification fans**

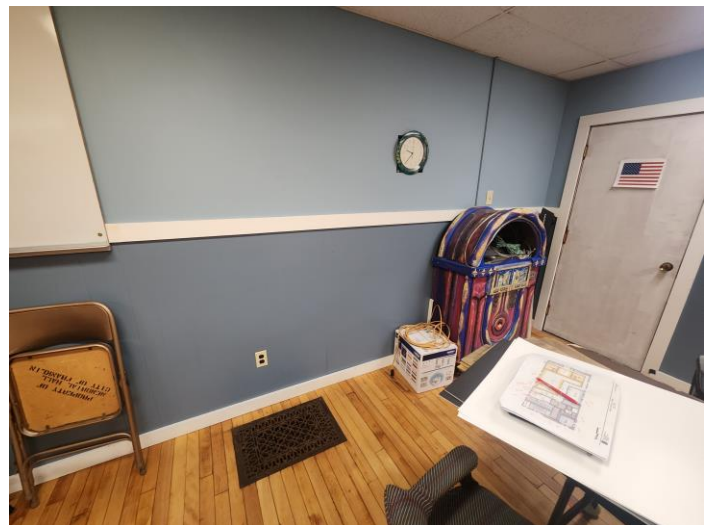
**Abandoned Floor grilles for old steam system**

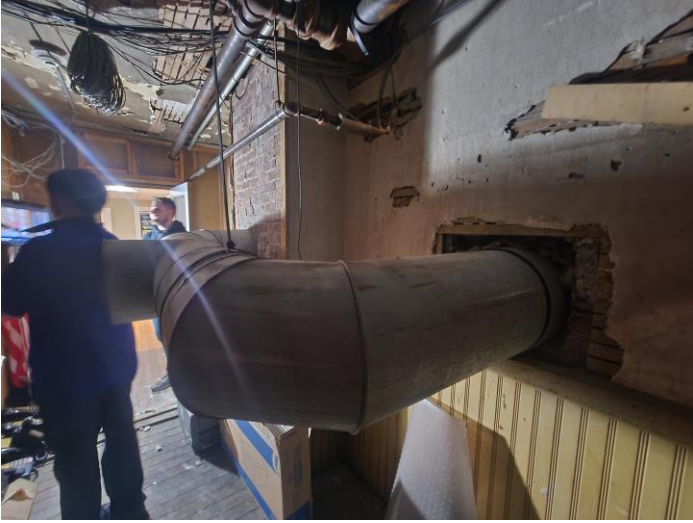
**Existing Boiler flue**

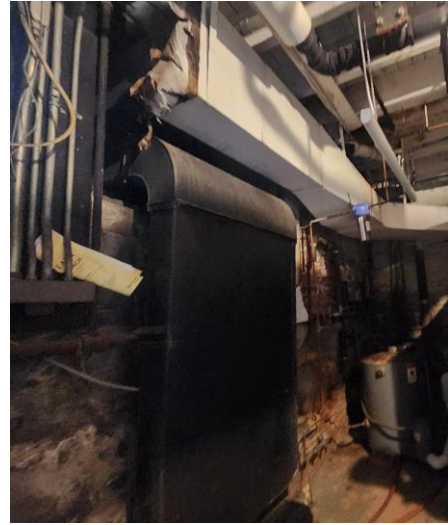
**Boiler combustion air and FCU outside air intake**

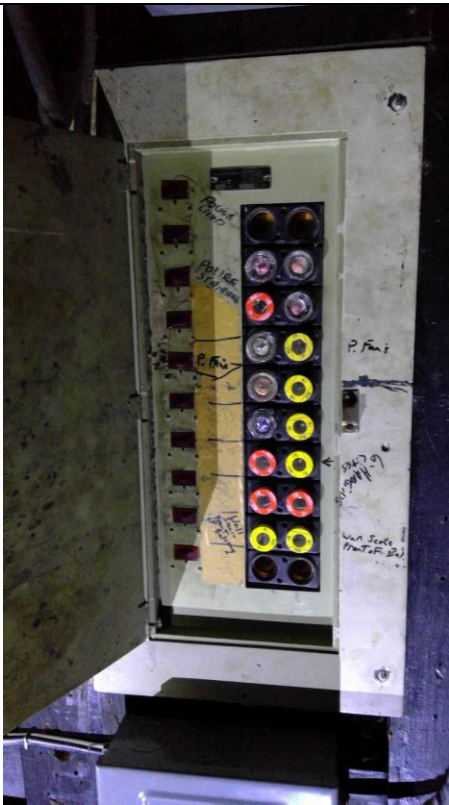
The existing distribution in the building is a variety of panelboards and fuse boxes. The electrical distribution in the building is located in the backstage area and in utility rooms in the basement. Panelboards are not labeled and do not have accurate panelboard directories. Several panelboards and fuse boxes located in the backstage area are located on a raised platform and do not meet NEC clearance requirements. Due to the general age of the distribution equipment, the rating is a 1 to a 2. All fuse boxes are rated a 1 and should be phased out and replaced.

**Existing Fuse Box**

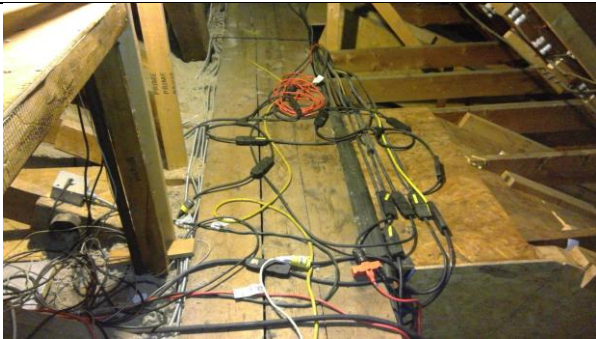
**Existing Show Lighting**

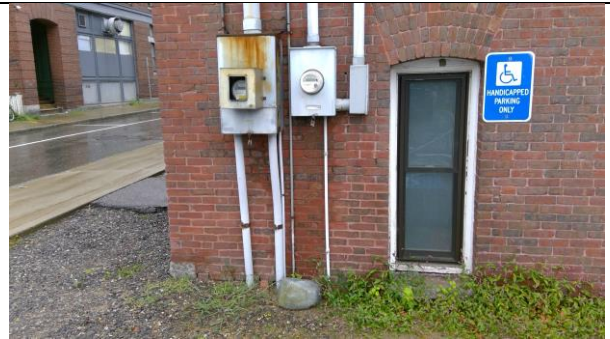
**Existing Electrical Meters**

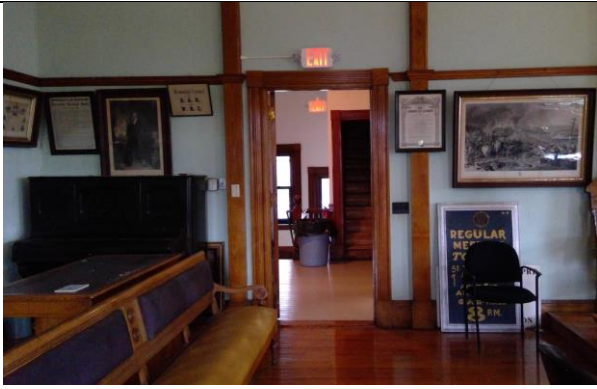
**Typical Exit Signage and Emergency Lighting**

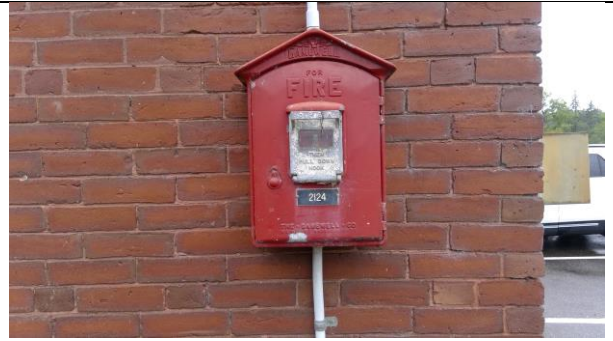
The existing fire alarm control panel is an addressable Mircom FX-2000 Control Panel that communicates to the fire department via a Gamewell master pull box. There is an abandoned in place FCI 12 zone conventional fire alarm control panel. Devices are located throughout the whole building. Pull stations were observed at each egress. Horn/strobe devices were observed in most areas, however, did not appear to provide full coverage. The existing building does not have sprinkler protection and therefore has smoke detectors throughout most of the building. The existing smoke detection did not appear to provide full coverage throughout the whole building. The rating of the existing fire alarm system is a 3.

**Fire Alarm master Pull Box**

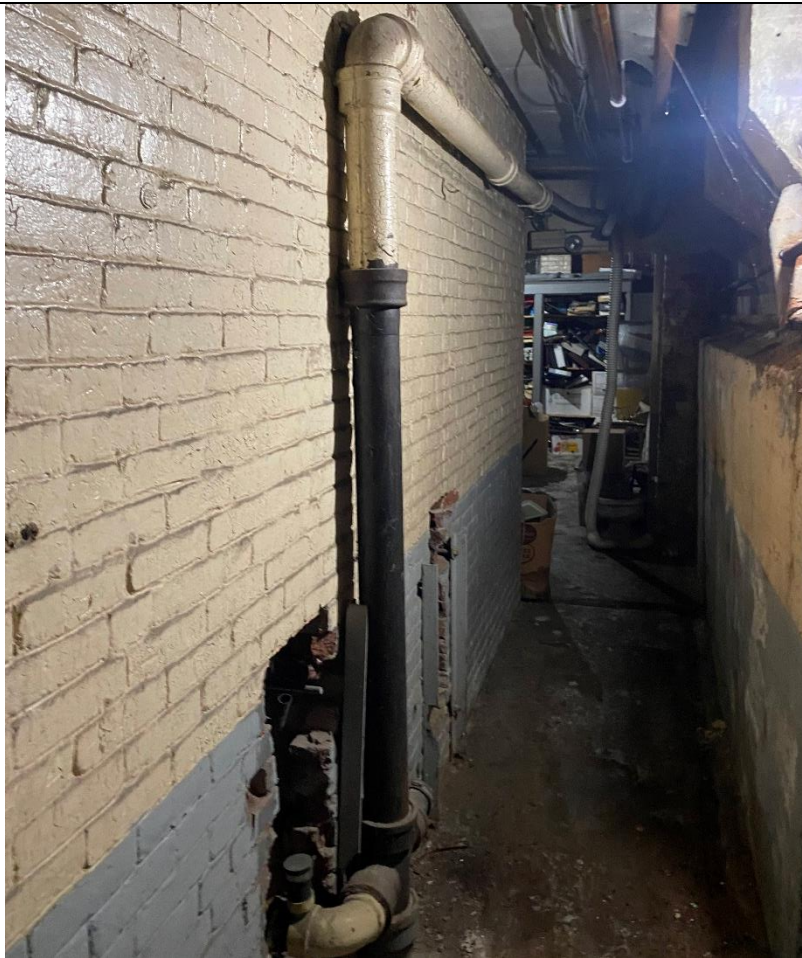
**Waste drop, Basement.**

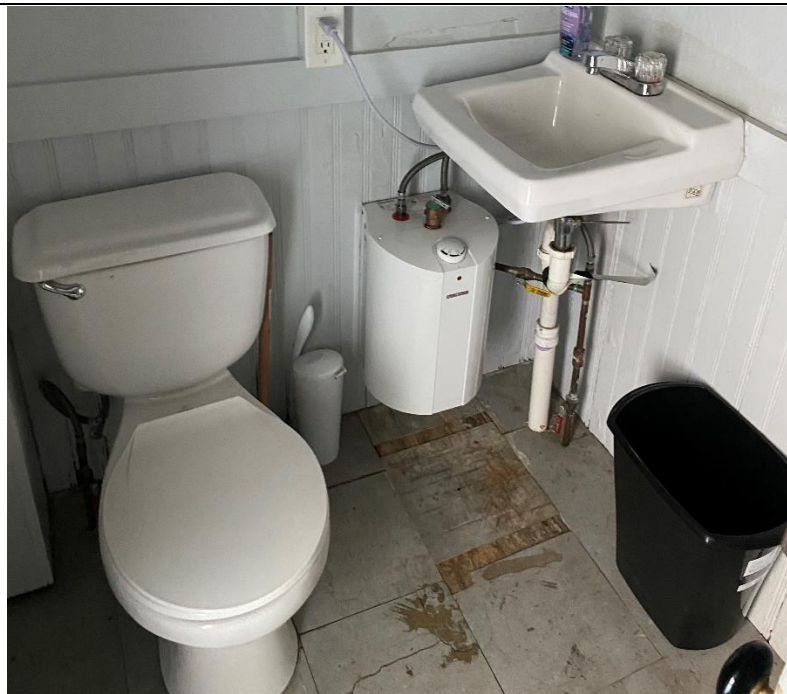
**Single Bathroom 1, Basement**

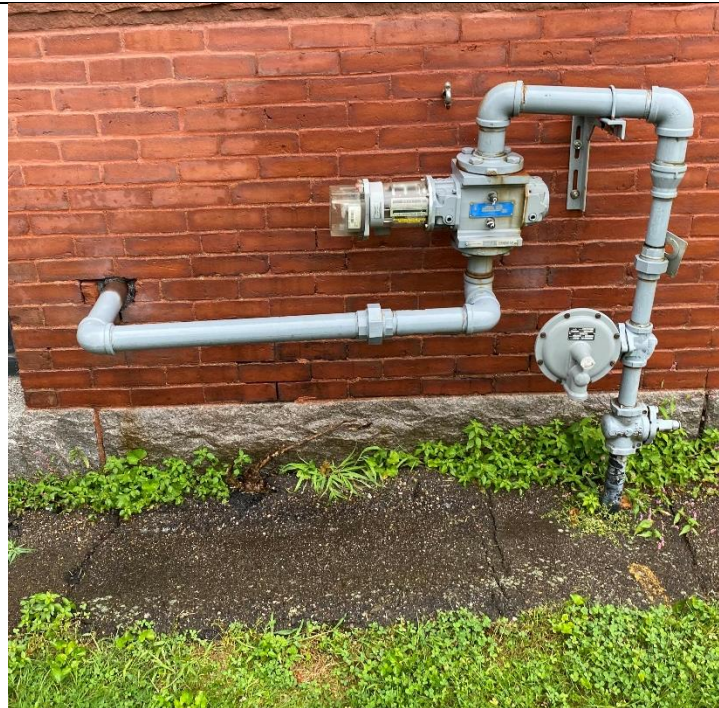
**Gas Entrance and Regulator, Exterior**

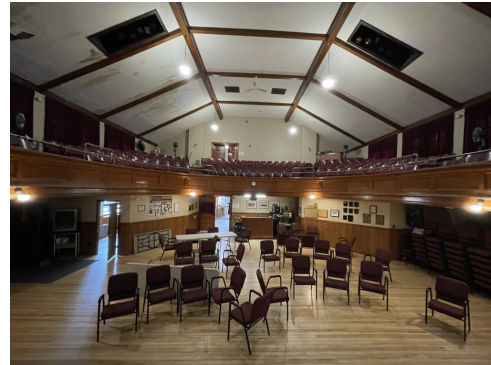
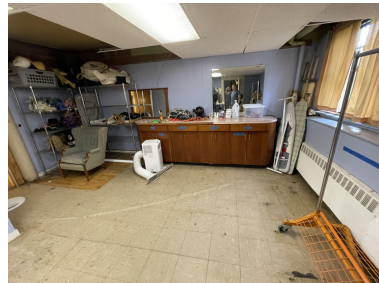
Figure 22.3

22.3	Women's dressing room is fairly large but is in need of updating and renovation.
	22.4	Men's Dressing room is quite small and in need of updating and renovation.
	22.5	There was not an apparent production break room at the time of assessment.
	22.6	Rehearsal room was not diminutive but is also not an adequate size to tape out the entire stage. Area is not column free.
